## Management Survey

Site: 49 Beach Road, Littlehampton, BN16 3SD  
UPRN: N/A  
Client: Dove Lodge  
Report No: J012312  
Survey Date: 3rd September 2018  
Report Date: 4th September 2018  
Surveyors: Michael Hayward

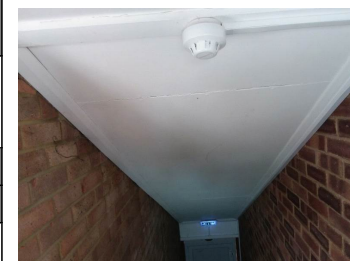
Picture 32

Sample ID	Building	Floor	Description	Room/Position	Extent (m2)	Fixing	Substrate	Asbestos Type Identified
MH000187	Dove Lodge, 49 Beach Road, Littlehampton, BN16 3SD	1st Floor	Asbestos Insulating Board	Area 2 - Fire Exit Stairwell to Ground Floor, Ceiling lining	6.0m <sup>2</sup>	Nailed	Timber Batons	Chrysotile + Amosite
<b>Recommendations</b>					<b>Assessment Scores</b>			<b>Risk Code</b>
					<b>Material</b>	<b>Priority</b>	<b>Total</b>	
High risk ACM in good condition, encapsulation intact. Where appropriate label with warning signs. Undertake routine inspections for damage and deterioration. Work on this material requires a license & is notifiable to the appropriate enforcing authority. Disposal of asbestos waste by a licensed contractor only. All work must conform to the 'Control of Asbestos Regulations 2012'.					5	5	10	Low
<b>Reinspection Due</b>		12 months	<b>Actions Taken</b>	N/A	<b>Time Scale</b>			<b>Action Completed Sign &amp; Date</b>

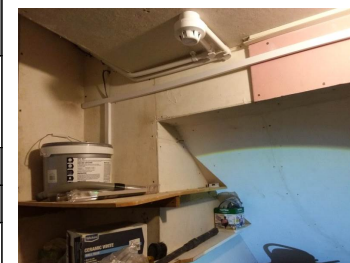
Picture 42

Sample ID	Building	Floor	Description	Room/Position	Extent (m2)	Fixing	Substrate	Asbestos Type Identified
MH000188	Dove Lodge, 49 Beach Road, Littlehampton, BN16 3SD	Ground Floor	Asbestos Insulating Board	Hallway - Understairs Gas Cupboard, stair backing and wall lining	9.0m <sup>2</sup>	Screwed	Timber Batons	Chrysotile + Amosite
<b>Recommendations</b>					<b>Assessment Scores</b>			<b>Risk Code</b>
					<b>Material</b>	<b>Priority</b>	<b>Total</b>	
Remove, repair or encapsulate by a licenced asbestos contractor under controlled conditions. Work on this material requires a license & is notifiable to the appropriate enforcing authority. Disposal of asbestos waste by a licensed contractor only. All work must conform to the 'Control of Asbestos Regulations 2012'.					7	5	12	Low
<b>Reinspection Due</b>		12 months	<b>Actions Taken</b>	N/A	<b>Time Scale</b>			<b>Action Completed Sign &amp; Date</b>

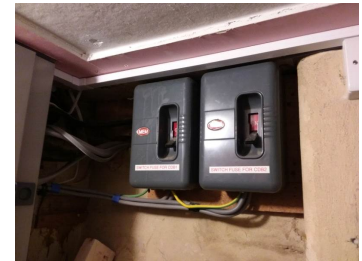
Picture 44

Sample ID	Building	Floor	Description	Room/Position	Extent (m2)	Fixing	Substrate	Asbestos Type Identified
Visual	Dove Lodge, 49 Beach Road, Littlehampton, BN16 3SD	Ground Floor	Textiles	Hallway - Understairs Gas Cupboard, Flashguards	<1.0m	Bonded	Metal	Chrysotile
<b>Recommendations</b>					<b>Assessment Scores</b>			<b>Risk Code</b>
					<b>Material</b>	<b>Priority</b>	<b>Total</b>	
Inaccessible further investigation is required. To determine the material, access, sampling and analysis would be required. Until this is carried out it must be presumed to be an ACM (Asbestos Containing Material).					5	4	9	Low
<b>Reinspection Due</b>		12 months	<b>Actions Taken</b>	N/A	<b>Time Scale</b>			<b>Action Completed Sign &amp; Date</b>

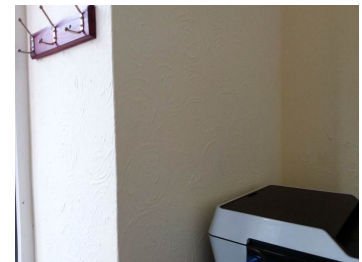
Picture 46

Sample ID	Building	Floor	Description	Room/Position	Extent (m2)	Fixing	Substrate	Asbestos Type Identified
MH000190	Dove Lodge, 49 Beach Road, Littlehampton, BN16 3SD	Ground Floor	Textured Coating/Decorative Finish	Dove Lodge Reception, to Walls	24.0m²	Bonded	Brick	Chrysotile
<b>Recommendations</b>					<b>Assessment Scores</b>			<b>Risk Code</b>
					<b>Material</b>	<b>Priority</b>	<b>Total</b>	
Low risk ACM (Bound in matrix). Where appropriate label with warning signs. Undertake routine inspections for damage and deterioration. Work on this material does not require a license. Work on this material may be notifiable to the appropriate enforcing authority. Disposal of asbestos waste by a licensed contractor only. All work must conform to the 'Control of Asbestos Regulations 2012'.					4	7	11	Low
<b>Reinspection Due</b>		12 months	<b>Actions Taken</b>	N/A	<b>Time Scale</b>			<b>Action Completed Sign &amp; Date</b>

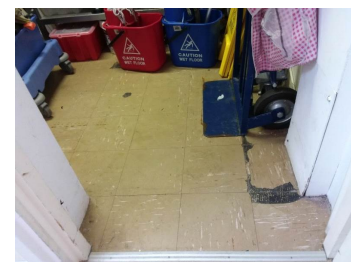
Picture 55

Sample ID	Building	Floor	Description	Room/Position	Extent (m2)	Fixing	Substrate	Asbestos Type Identified
MH000193	Dove Lodge, 49 Beach Road, Littlehampton, BN16 3SD	Ground Floor	Flooring - Thermoplastic	Dove Store, Floor tiles	6.0m <sup>2</sup>	Bonded	Concrete	Chrysotile
<b>Recommendations</b>					<b>Assessment Scores</b>			<b>Risk Code</b>
<p>Low risk ACM (Bound in matrix). Where appropriate label with warning signs. Undertake routine inspections for damage and deterioration. Work on this material does not require a license. Work on this material may be notifiable to the appropriate enforcing authority. Disposal of asbestos waste by a licensed contractor only. All work must conform to the 'Control of Asbestos Regulations 2012'.</p>					<b>Material</b>	<b>Priority</b>	<b>Total</b>	<p>Low</p>
					3	6	9	
<b>Reinspection Due</b>		12 months	<b>Actions Taken</b>	N/A	<b>Time Scale</b>		<b>Action Completed Sign &amp; Date</b>

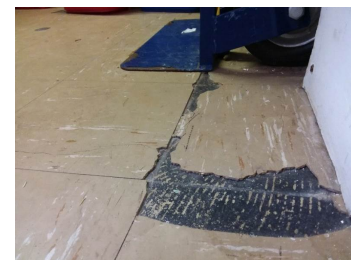
Picture 56

Sample ID	Building	Floor	Description	Room/Position	Extent (m2)	Fixing	Substrate	Asbestos Type Identified
MH000194	Dove Lodge, 49 Beach Road, Littlehampton, BN16 3SD	Ground Floor	Bitumen Products	Dove Store, Floor Adhesive	6.0m <sup>2</sup>	Bonded	Concrete	Chrysotile
<b>Recommendations</b>					<b>Assessment Scores</b>			<b>Risk Code</b>
<p>Low risk ACM (Bound in matrix). Where appropriate label with warning signs. Undertake routine inspections for damage and deterioration. Work on this material does not require a license. Work on this material may be notifiable to the appropriate enforcing authority. Disposal of asbestos waste by a licensed contractor only. All work must conform to the 'Control of Asbestos Regulations 2012'.</p>					<b>Material</b>	<b>Priority</b>	<b>Total</b>	<p>Very Low</p>
					2	6	8	
<b>Reinspection Due</b>		12 months	<b>Actions Taken</b>	N/A	<b>Time Scale</b>		<b>Action Completed Sign &amp; Date</b>

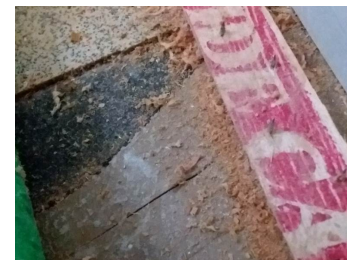
Picture 58

Sample ID	Building	Floor	Description	Room/Position	Extent (m2)	Fixing	Substrate	Asbestos Type Identified
As MH000193	Dove Lodge, 49 Beach Road, Littlehampton, BN16 3SD	Ground Floor	Flooring - Thermoplastic	Directors Office, Floor tiles	6.0m <sup>2</sup>	Bonded	Concrete	Chrysotile
<b>Recommendations</b>					<b>Assessment Scores</b>			<b>Risk Code</b>
<p>Low risk ACM (Bound in matrix). Where appropriate label with warning signs. Undertake routine inspections for damage and deterioration. Work on this material does not require a license. Work on this material may be notifiable to the appropriate enforcing authority. Disposal of asbestos waste by a licensed contractor only. All work must conform to the 'Control of Asbestos Regulations 2012'.</p>					<b>Material</b>	<b>Priority</b>	<b>Total</b>	Low
					3	6	9	
<b>Reinspection Due</b>		12 months	<b>Actions Taken</b>	N/A	<b>Time Scale</b>		<b>Action Completed Sign &amp; Date</b>

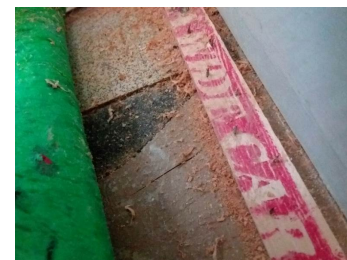
Picture 59

Sample ID	Building	Floor	Description	Room/Position	Extent (m2)	Fixing	Substrate	Asbestos Type Identified
As MH000194	Dove Lodge, 49 Beach Road, Littlehampton, BN16 3SD	Ground Floor	Bitumen Products	Directors Office, Floor Adhesive	6.0m <sup>2</sup>	Bonded	Concrete	Chrysotile
<b>Recommendations</b>					<b>Assessment Scores</b>			<b>Risk Code</b>
<p>Low risk ACM (Bound in matrix). Where appropriate label with warning signs. Undertake routine inspections for damage and deterioration. Work on this material does not require a license. Work on this material may be notifiable to the appropriate enforcing authority. Disposal of asbestos waste by a licensed contractor only. All work must conform to the 'Control of Asbestos Regulations 2012'.</p>					<b>Material</b>	<b>Priority</b>	<b>Total</b>	Very Low
					2	6	8	
<b>Reinspection Due</b>		12 months	<b>Actions Taken</b>	N/A	<b>Time Scale</b>		<b>Action Completed Sign &amp; Date</b>

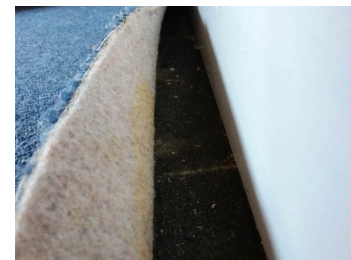
Picture 64

Sample ID	Building	Floor	Description	Room/Position	Extent (m2)	Fixing	Substrate	Asbestos Type Identified
As MH000194	Dove Lodge, 49 Beach Road, Littlehampton, BN16 3SD	Ground Floor	Bitumen Products	Room 6, Floor Adhesive	9.0m <sup>2</sup>	Bonded	Concrete	Chrysotile
<b>Recommendations</b>					<b>Assessment Scores</b>			<b>Risk Code</b>
<p>Low risk ACM (Bound in matrix). Where appropriate label with warning signs. Undertake routine inspections for damage and deterioration. Work on this material does not require a license. Work on this material may be notifiable to the appropriate enforcing authority. Disposal of asbestos waste by a licensed contractor only. All work must conform to the 'Control of Asbestos Regulations 2012'.</p>					<b>Material</b>	<b>Priority</b>	<b>Total</b>	Low
					2	7	9	
<b>Reinspection Due</b>		12 months	<b>Actions Taken</b>	N/A	<b>Time Scale</b>		<b>Action Completed Sign &amp; Date</b>

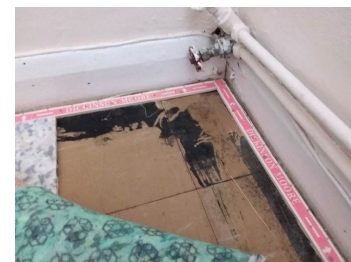
Picture 70

Sample ID	Building	Floor	Description	Room/Position	Extent (m2)	Fixing	Substrate	Asbestos Type Identified
As MH000194	Dove Lodge, 49 Beach Road, Littlehampton, BN16 3SD	Ground Floor	Bitumen Products	Room 9, Floor Adhesive	20.0m <sup>2</sup>	Bonded	Concrete	Chrysotile
<b>Recommendations</b>					<b>Assessment Scores</b>			<b>Risk Code</b>
<p>Low risk ACM (Bound in matrix). Where appropriate label with warning signs. Undertake routine inspections for damage and deterioration. Work on this material does not require a license. Work on this material may be notifiable to the appropriate enforcing authority. Disposal of asbestos waste by a licensed contractor only. All work must conform to the 'Control of Asbestos Regulations 2012'.</p>					<b>Material</b>	<b>Priority</b>	<b>Total</b>	Low
					2	7	9	
<b>Reinspection Due</b>		12 months	<b>Actions Taken</b>	N/A	<b>Time Scale</b>		<b>Action Completed Sign &amp; Date</b>

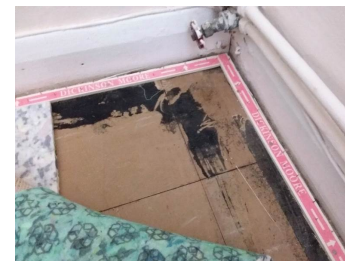
Picture 71

Sample ID	Building	Floor	Description	Room/Position	Extent (m2)	Fixing	Substrate	Asbestos Type Identified
As MH000193	Dove Lodge, 49 Beach Road, Littlehampton, BN16 3SD	Ground Floor	Flooring - Thermoplastic	Room 9, Floor tiles	20.0m <sup>2</sup>	Bonded	Concrete	Chrysotile
<b>Recommendations</b>					<b>Assessment Scores</b>			<b>Risk Code</b>
<p>Low risk ACM (Bound in matrix). Where appropriate label with warning signs. Undertake routine inspections for damage and deterioration. Work on this material does not require a license. Work on this material may be notifiable to the appropriate enforcing authority. Disposal of asbestos waste by a licensed contractor only. All work must conform to the 'Control of Asbestos Regulations 2012'.</p>					<b>Material</b>	<b>Priority</b>	<b>Total</b>	Low
					3	7	10	
<b>Reinspection Due</b>		12 months	<b>Actions Taken</b>	N/A	<b>Time Scale</b>			<b>Action Completed Sign &amp; Date</b>

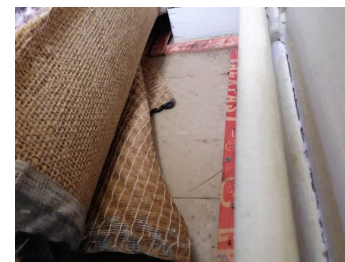
Picture 72

Sample ID	Building	Floor	Description	Room/Position	Extent (m2)	Fixing	Substrate	Asbestos Type Identified
As MH000193	Dove Lodge, 49 Beach Road, Littlehampton, BN16 3SD	Ground Floor	Flooring - Thermoplastic	Room 10, Floor tiles	20.0m <sup>2</sup>	Bonded	Concrete	Chrysotile
<b>Recommendations</b>					<b>Assessment Scores</b>			<b>Risk Code</b>
<p>Low risk ACM (Bound in matrix). Where appropriate label with warning signs. Undertake routine inspections for damage and deterioration. Work on this material does not require a license. Work on this material may be notifiable to the appropriate enforcing authority. Disposal of asbestos waste by a licensed contractor only. All work must conform to the 'Control of Asbestos Regulations 2012'.</p>					<b>Material</b>	<b>Priority</b>	<b>Total</b>	Low
					3	7	10	
<b>Reinspection Due</b>		12 months	<b>Actions Taken</b>	N/A	<b>Time Scale</b>			<b>Action Completed Sign &amp; Date</b>

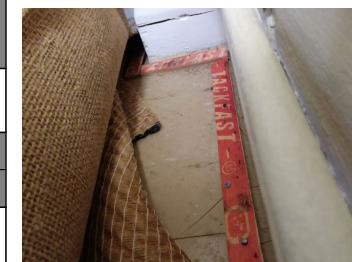
Picture 73

Sample ID	Building	Floor	Description	Room/Position	Extent (m2)	Fixing	Substrate	Asbestos Type Identified
As MH000194	Dove Lodge, 49 Beach Road, Littlehampton, BN16 3SD	Ground Floor	Bitumen Products	Room 10, Floor Adhesive	20.0m <sup>2</sup>	Bonded	Concrete	Chrysotile
<b>Recommendations</b>					<b>Assessment Scores</b>			<b>Risk Code</b>
					<b>Material</b>	<b>Priority</b>	<b>Total</b>	
Low risk ACM (Bound in matrix). Where appropriate label with warning signs. Undertake routine inspections for damage and deterioration. Work on this material does not require a license. Work on this material may be notifiable to the appropriate enforcing authority. Disposal of asbestos waste by a licensed contractor only. All work must conform to the 'Control of Asbestos Regulations 2012'.					2	7	9	Low
<b>Reinspection Due</b>		12 months	<b>Actions Taken</b>	N/A	<b>Time Scale</b>			<b>Action Completed Sign &amp; Date</b>

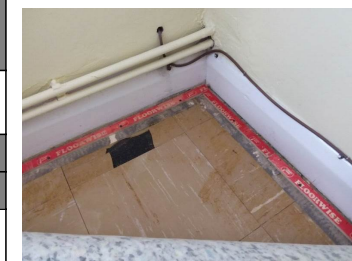
Picture 74

Sample ID	Building	Floor	Description	Room/Position	Extent (m2)	Fixing	Substrate	Asbestos Type Identified
As MH000193	Dove Lodge, 49 Beach Road, Littlehampton, BN16 3SD	Ground Floor	Flooring - Thermoplastic	Room 11, Floor tiles	20.0m <sup>2</sup>	Bonded	Concrete	Chrysotile
<b>Recommendations</b>					<b>Assessment Scores</b>			<b>Risk Code</b>
					<b>Material</b>	<b>Priority</b>	<b>Total</b>	
Low risk ACM (Bound in matrix). Where appropriate label with warning signs. Undertake routine inspections for damage and deterioration. Work on this material does not require a license. Work on this material may be notifiable to the appropriate enforcing authority. Disposal of asbestos waste by a licensed contractor only. All work must conform to the 'Control of Asbestos Regulations 2012'.					3	7	10	Low
<b>Reinspection Due</b>		12 months	<b>Actions Taken</b>	N/A	<b>Time Scale</b>			<b>Action Completed Sign &amp; Date</b>

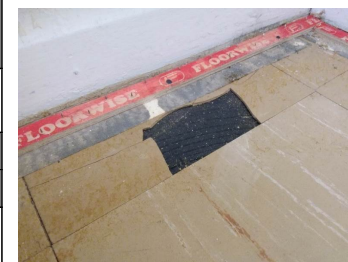
Picture 75

Sample ID	Building	Floor	Description	Room/Position	Extent (m <sup>2</sup> )	Fixing	Substrate	Asbestos Type Identified
As MH000194	Dove Lodge, 49 Beach Road, Littlehampton, BN16 3SD	Ground Floor	Bitumen Products	Room 11, Floor Adhesive	20.0m <sup>2</sup>	Bonded	Concrete	Chrysotile
<b>Recommendations</b>					<b>Assessment Scores</b>			<b>Risk Code</b>
<p>Low risk ACM (Bound in matrix). Where appropriate label with warning signs. Undertake routine inspections for damage and deterioration. Work on this material does not require a license. Work on this material may be notifiable to the appropriate enforcing authority. Disposal of asbestos waste by a licensed contractor only. All work must conform to the 'Control of Asbestos Regulations 2012'.</p>					<b>Material</b>	<b>Priority</b>	<b>Total</b>	Low
					2	7	9	
<b>Reinspection Due</b>		12 months	<b>Actions Taken</b>	N/A	<b>Time Scale</b>		<b>Action Completed Sign &amp; Date</b>

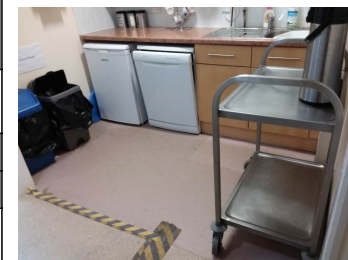
Picture 77

Sample ID	Building	Floor	Description	Room/Position	Extent (m <sup>2</sup> )	Fixing	Substrate	Asbestos Type Identified
As MH000194	Dove Lodge, 49 Beach Road, Littlehampton, BN16 3SD	Ground Floor	Bitumen Products	Kitchenette, Floor Adhesive	6.0m <sup>2</sup>	Bonded	Concrete	Chrysotile
<b>Recommendations</b>					<b>Assessment Scores</b>			<b>Risk Code</b>
<p>Low risk ACM (Bound in matrix). Where appropriate label with warning signs. Undertake routine inspections for damage and deterioration. Work on this material does not require a license. Work on this material may be notifiable to the appropriate enforcing authority. Disposal of asbestos waste by a licensed contractor only. All work must conform to the 'Control of Asbestos Regulations 2012'.</p>					<b>Material</b>	<b>Priority</b>	<b>Total</b>	Very Low
					2	6	8	
<b>Reinspection Due</b>		12 months	<b>Actions Taken</b>	N/A	<b>Time Scale</b>		<b>Action Completed Sign &amp; Date</b>

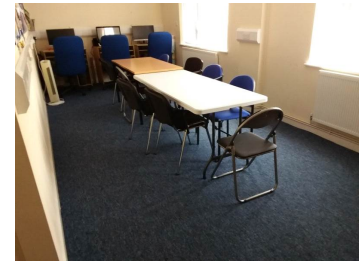
Picture 78

Sample ID	Building	Floor	Description	Room/Position	Extent (m2)	Fixing	Substrate	Asbestos Type Identified
As MH000194	Dove Lodge, 49 Beach Road, Littlehampton, BN16 3SD	Ground Floor	Bitumen Products	Room 8 (including cupboard), Floor Adhesive	24.0m <sup>2</sup>	Bonded	Concrete	Chrysotile
<b>Recommendations</b>					<b>Assessment Scores</b>			<b>Risk Code</b>
					<b>Material</b>	<b>Priority</b>	<b>Total</b>	
<p>Low risk ACM (Bound in matrix). Where appropriate label with warning signs. Undertake routine inspections for damage and deterioration. Work on this material does not require a license. Work on this material may be notifiable to the appropriate enforcing authority. Disposal of asbestos waste by a licensed contractor only. All work must conform to the 'Control of Asbestos Regulations 2012'.</p>					2	7	9	Low
<b>Reinspection Due</b>		12 months	<b>Actions Taken</b>	N/A	<b>Time Scale</b>			<b>Action Completed Sign &amp; Date</b>

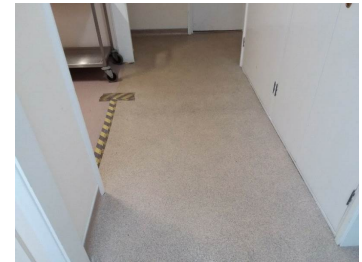
Picture 79

Sample ID	Building	Floor	Description	Room/Position	Extent (m2)	Fixing	Substrate	Asbestos Type Identified
As MH000193	Dove Lodge, 49 Beach Road, Littlehampton, BN16 3SD	Ground Floor	Flooring - Thermoplastic	kitchenette Lobby Corridor, Floor tiles	10.0m <sup>2</sup>	Bonded	Concrete	Chrysotile
<b>Recommendations</b>					<b>Assessment Scores</b>			<b>Risk Code</b>
					<b>Material</b>	<b>Priority</b>	<b>Total</b>	
<p>Low risk ACM (Bound in matrix). Where appropriate label with warning signs. Undertake routine inspections for damage and deterioration. Work on this material does not require a license. Work on this material may be notifiable to the appropriate enforcing authority. Disposal of asbestos waste by a licensed contractor only. All work must conform to the 'Control of Asbestos Regulations 2012'.</p>					2	5	7	Very Low
<b>Reinspection Due</b>		12 months	<b>Actions Taken</b>	N/A	<b>Time Scale</b>			<b>Action Completed Sign &amp; Date</b>

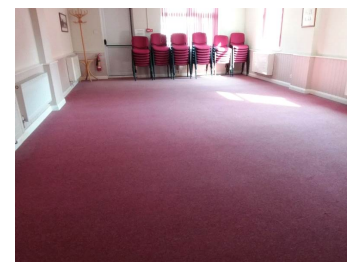
Picture 82

Sample ID	Building	Floor	Description	Room/Position	Extent (m2)	Fixing	Substrate	Asbestos Type Identified
As MH000194	Dove Lodge, 49 Beach Road, Littlehampton, BN16 3SD	Ground Floor	Bitumen Products	The Amberley Room, Floor Adhesive	52.0m <sup>2</sup>	Bonded	Concrete	Chrysotile
<b>Recommendations</b>					<b>Assessment Scores</b>			<b>Risk Code</b>
					<b>Material</b>	<b>Priority</b>	<b>Total</b>	
Low risk ACM (Bound in matrix). Where appropriate label with warning signs. Undertake routine inspections for damage and deterioration. Work on this material does not require a license. Work on this material may be notifiable to the appropriate enforcing authority. Disposal of asbestos waste by a licensed contractor only. All work must conform to the 'Control of Asbestos Regulations 2012'.					2	7	9	Low
<b>Reinspection Due</b>		12 months	<b>Actions Taken</b>	N/A	<b>Time Scale</b>		<b>Action Completed Sign &amp; Date</b>

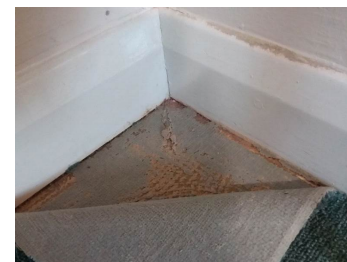
Picture 83

Sample ID	Building	Floor	Description	Room/Position	Extent (m2)	Fixing	Substrate	Asbestos Type Identified
As MH000193	Dove Lodge, 49 Beach Road, Littlehampton, BN16 3SD	Ground Floor	Flooring - Thermoplastic	Room 5, Floor tiles	15.0m <sup>2</sup>	Bonded	Concrete	Chrysotile
<b>Recommendations</b>					<b>Assessment Scores</b>			<b>Risk Code</b>
					<b>Material</b>	<b>Priority</b>	<b>Total</b>	
Low risk ACM (Bound in matrix). Where appropriate label with warning signs. Undertake routine inspections for damage and deterioration. Work on this material does not require a license. Work on this material may be notifiable to the appropriate enforcing authority. Disposal of asbestos waste by a licensed contractor only. All work must conform to the 'Control of Asbestos Regulations 2012'.					3	7	10	Low
<b>Reinspection Due</b>		12 months	<b>Actions Taken</b>	N/A	<b>Time Scale</b>		<b>Action Completed Sign &amp; Date</b>

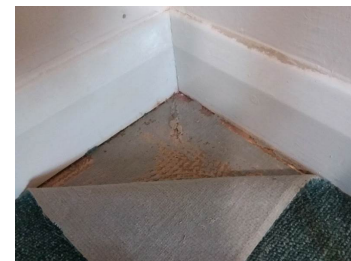
Picture 84

Sample ID	Building	Floor	Description	Room/Position	Extent (m2)	Fixing	Substrate	Asbestos Type Identified
As MH000194	Dove Lodge, 49 Beach Road, Littlehampton, BN16 3SD	Ground Floor	Floor Adhesive	Room 5, Floor Adhesive	15.0m <sup>2</sup>	Bonded	Concrete	Chrysotile
<b>Recommendations</b>					<b>Assessment Scores</b>			<b>Risk Code</b>
<p>Low risk ACM (Bound in matrix). Where appropriate label with warning signs. Undertake routine inspections for damage and deterioration. Work on this material does not require a license. Work on this material may be notifiable to the appropriate enforcing authority. Disposal of asbestos waste by a licensed contractor only. All work must conform to the 'Control of Asbestos Regulations 2012'.</p>					<b>Material</b>	<b>Priority</b>	<b>Total</b>	Low
					2	8	10	
<b>Reinspection Due</b>		12 months	<b>Actions Taken</b>	N/A	<b>Time Scale</b>		<b>Action Completed Sign &amp; Date</b>

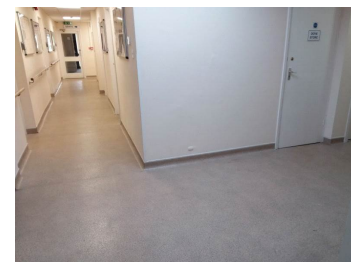
Picture 85

Sample ID	Building	Floor	Description	Room/Position	Extent (m2)	Fixing	Substrate	Asbestos Type Identified
As MH000193	Dove Lodge, 49 Beach Road, Littlehampton, BN16 3SD	Ground Floor	Flooring - Thermoplastic	Amberley Corridor, Floor tiles	50.0m <sup>2</sup>	Bonded	Concrete	Chrysotile
<b>Recommendations</b>					<b>Assessment Scores</b>			<b>Risk Code</b>
<p>Low risk ACM (Bound in matrix). Where appropriate label with warning signs. Undertake routine inspections for damage and deterioration. Work on this material does not require a license. Work on this material may be notifiable to the appropriate enforcing authority. Disposal of asbestos waste by a licensed contractor only. All work must conform to the 'Control of Asbestos Regulations 2012'.</p>					<b>Material</b>	<b>Priority</b>	<b>Total</b>	Low
					3	6	9	
<b>Reinspection Due</b>		12 months	<b>Actions Taken</b>	N/A	<b>Time Scale</b>		<b>Action Completed Sign &amp; Date</b>

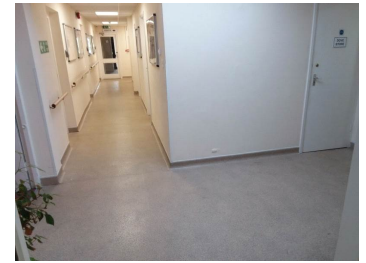
Picture 86

Sample ID	Building	Floor	Description	Room/Position	Extent (m2)	Fixing	Substrate	Asbestos Type Identified
As MH000194	Dove Lodge, 49 Beach Road, Littlehampton, BN16 3SD	Ground Floor	Floor Adhesive	Amberley Corridor, Floor Adhesive	50.0m <sup>2</sup>	Bonded	Concrete	Chrysotile
<b>Recommendations</b>					<b>Assessment Scores</b>			<b>Risk Code</b>
					<b>Material</b>	<b>Priority</b>	<b>Total</b>	
Low risk ACM (Bound in matrix). Where appropriate label with warning signs. Undertake routine inspections for damage and deterioration. Work on this material does not require a license. Work on this material may be notifiable to the appropriate enforcing authority. Disposal of asbestos waste by a licensed contractor only. All work must conform to the 'Control of Asbestos Regulations 2012'.					2	6	8	Very Low
<b>Reinspection Due</b>		12 months	<b>Actions Taken</b>	N/A	<b>Time Scale</b>			<b>Action Completed Sign &amp; Date</b>

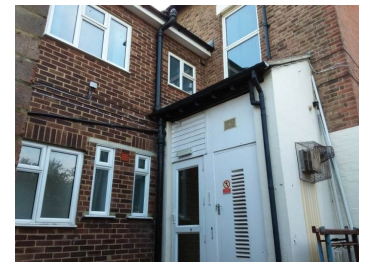
Picture 89

Sample ID	Building	Floor	Description	Room/Position	Extent (m2)	Fixing	Substrate	Asbestos Type Identified
MH000196	Dove Lodge, 49 Beach Road, Littlehampton, BN16 3SD	External	Cement	External Elements, Soilpipe to boiler room side of the building	7.0lm	Bolted	Brick	Chrysotile + Crocidolite
<b>Recommendations</b>					<b>Assessment Scores</b>			<b>Risk Code</b>
					<b>Material</b>	<b>Priority</b>	<b>Total</b>	
Low risk ACM (Bound in matrix). Where appropriate label with warning signs. Undertake routine inspections for damage and deterioration. Work on this material does not require a license. Work on this material may be notifiable to the appropriate enforcing authority. Disposal of asbestos waste by a licensed contractor only. All work must conform to the 'Control of Asbestos Regulations 2012'.					5	3	8	Very Low
<b>Reinspection Due</b>		12 months	<b>Actions Taken</b>	N/A	<b>Time Scale</b>			<b>Action Completed Sign &amp; Date</b>

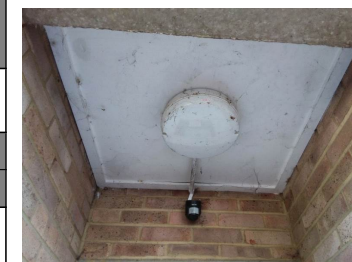
Picture 90

Sample ID	Building	Floor	Description	Room/Position	Extent (m2)	Fixing	Substrate	Asbestos Type Identified
MH000197	Dove Lodge, 49 Beach Road, Littlehampton, BN16 3SD	External	Asbestos Insulating Board	External Elements, Fire Exit Ceiling Lining	1.0m <sup>2</sup>	Nailed	Timber Batons	Chrysotile + Amosite
<b>Recommendations</b>					<b>Assessment Scores</b>			<b>Risk Code</b>
					<b>Material</b>	<b>Priority</b>	<b>Total</b>	
High risk ACM in good condition, encapsulation intact. Where appropriate label with warning signs. Undertake routine inspections for damage and deterioration. Work on this material requires a license & is notifiable to the appropriate enforcing authority. Disposal of asbestos waste by a licensed contractor only. All work must conform to the 'Control of Asbestos Regulations 2012'.					5	4	9	Low
<b>Reinspection Due</b>		12 months	<b>Actions Taken</b>	N/A	<b>Time Scale</b>			<b>Action Completed Sign &amp; Date</b>

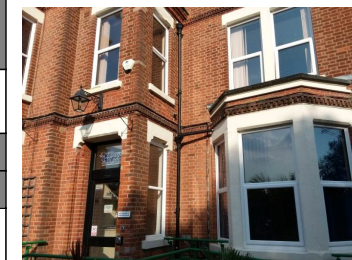
Picture 91

Sample ID	Building	Floor	Description	Room/Position	Extent (m2)	Fixing	Substrate	Asbestos Type Identified
MH000198	Dove Lodge, 49 Beach Road, Littlehampton, BN16 3SD	External	Cement	External Elements, Downpipe to front of building	6.0lm	Bolted	Brick	Chrysotile
<b>Recommendations</b>					<b>Assessment Scores</b>			<b>Risk Code</b>
					<b>Material</b>	<b>Priority</b>	<b>Total</b>	
Low risk ACM (Bound in matrix). Where appropriate label with warning signs. Undertake routine inspections for damage and deterioration. Work on this material does not require a license. Work on this material may be notifiable to the appropriate enforcing authority. Disposal of asbestos waste by a licensed contractor only. All work must conform to the 'Control of Asbestos Regulations 2012'.					3	4	7	Very Low
<b>Reinspection Due</b>		12 months	<b>Actions Taken</b>	N/A	<b>Time Scale</b>			<b>Action Completed Sign &amp; Date</b>

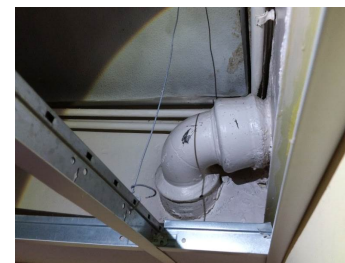
Picture 92

Sample ID	Building	Floor	Description	Room/Position	Extent (m2)	Fixing	Substrate	Asbestos Type Identified
As MH000196	Dove Lodge, 49 Beach Road, Littlehampton, BN16 3SD	Ground Floor	Cement	Amberley Corridor - Fire Exit 1, Soilpipe to boiler room side	1.0lm	Bolted	Brick	Chrysotile + Crocidolite
<b>Recommendations</b>					<b>Assessment Scores</b>			<b>Risk Code</b>
					<b>Material</b>	<b>Priority</b>	<b>Total</b>	
Low risk ACM (Bound in matrix). Where appropriate label with warning signs. Undertake routine inspections for damage and deterioration. Work on this material does not require a license. Work on this material may be notifiable to the appropriate enforcing authority. Disposal of asbestos waste by a licensed contractor only. All work must conform to the 'Control of Asbestos Regulations 2012'.					5	4	9	Low
<b>Reinspection Due</b>		12 months	<b>Actions Taken</b>	N/A	<b>Time Scale</b>			<b>Action Completed Sign &amp; Date</b>

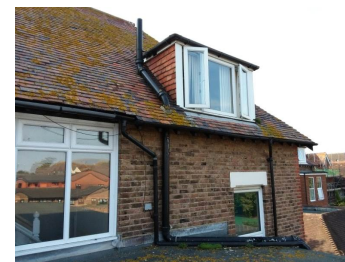
Picture 93

Sample ID	Building	Floor	Description	Room/Position	Extent (m2)	Fixing	Substrate	Asbestos Type Identified
As MH000196	Dove Lodge, 49 Beach Road, Littlehampton, BN16 3SD	External	Cement	External Elements, Soilpipe over flat roof to main building	5.0lm	Bolted	Brick	Chrysotile + Crocidolite
<b>Recommendations</b>					<b>Assessment Scores</b>			<b>Risk Code</b>
					<b>Material</b>	<b>Priority</b>	<b>Total</b>	
Low risk ACM (Bound in matrix). Where appropriate label with warning signs. Undertake routine inspections for damage and deterioration. Work on this material does not require a license. Work on this material may be notifiable to the appropriate enforcing authority. Disposal of asbestos waste by a licensed contractor only. All work must conform to the 'Control of Asbestos Regulations 2012'.					5	3	8	Very Low
<b>Reinspection Due</b>		12 months	<b>Actions Taken</b>	N/A	<b>Time Scale</b>			<b>Action Completed Sign &amp; Date</b>

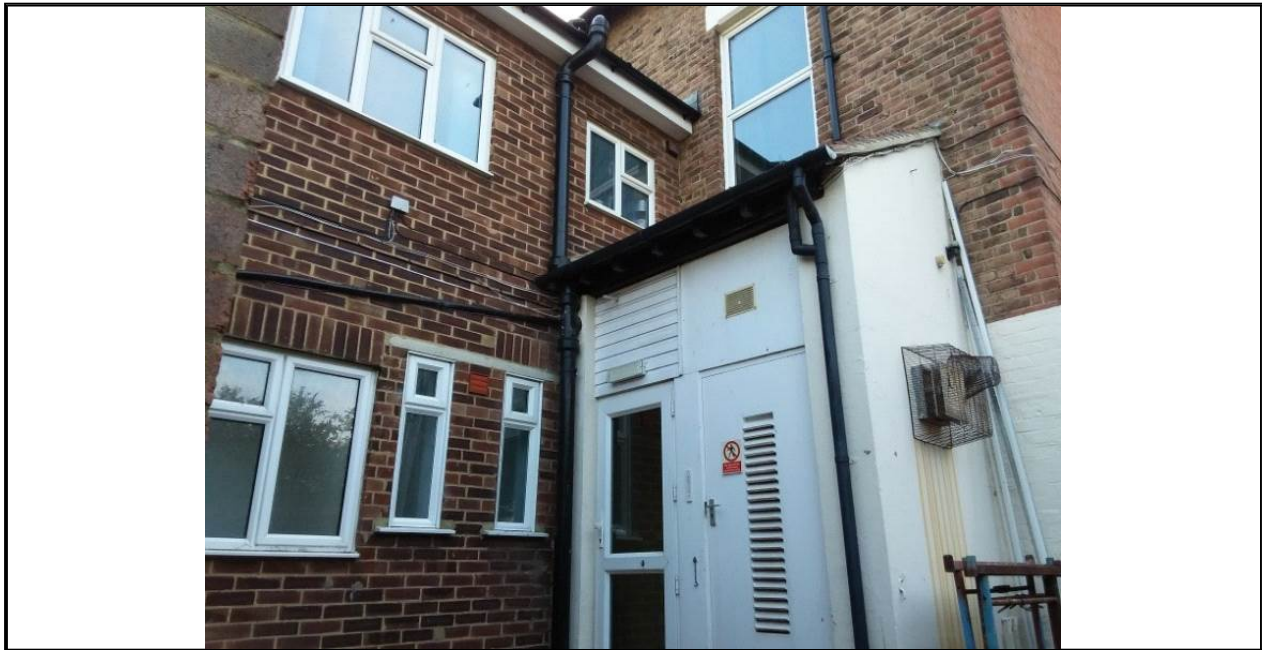
Sample No:	MH000196
Item No:	89
Survey Date:	03/09/18
Building:	Dove Lodge, 49 Beach Road, Littlehampton, BN16 3SD
Floor:	External
Room No:	External Elements
Position:	Soilpipe to boiler room side of the building - Cement
Extent:	7.0lm
Substrate:	Bolted, Brick
Material:	(1) Asbestos Cement
Accessibility:	(2) Easily disturbed
Asbestos Type:	Chrysotile + Crocidolite
Risk Category:	Very Low
Recommended Action:	Low risk ACM (Bound in matrix). Where appropriate label with warning signs. Undertake routine inspections for damage and deterioration. Work on this material does not require a license. Work on this material may be notifiable to the appropriate enforcing authority. Disposal of asbestos waste by a licensed contractor only. All work must conform to the 'Control of Asbestos Regulations 2012'.

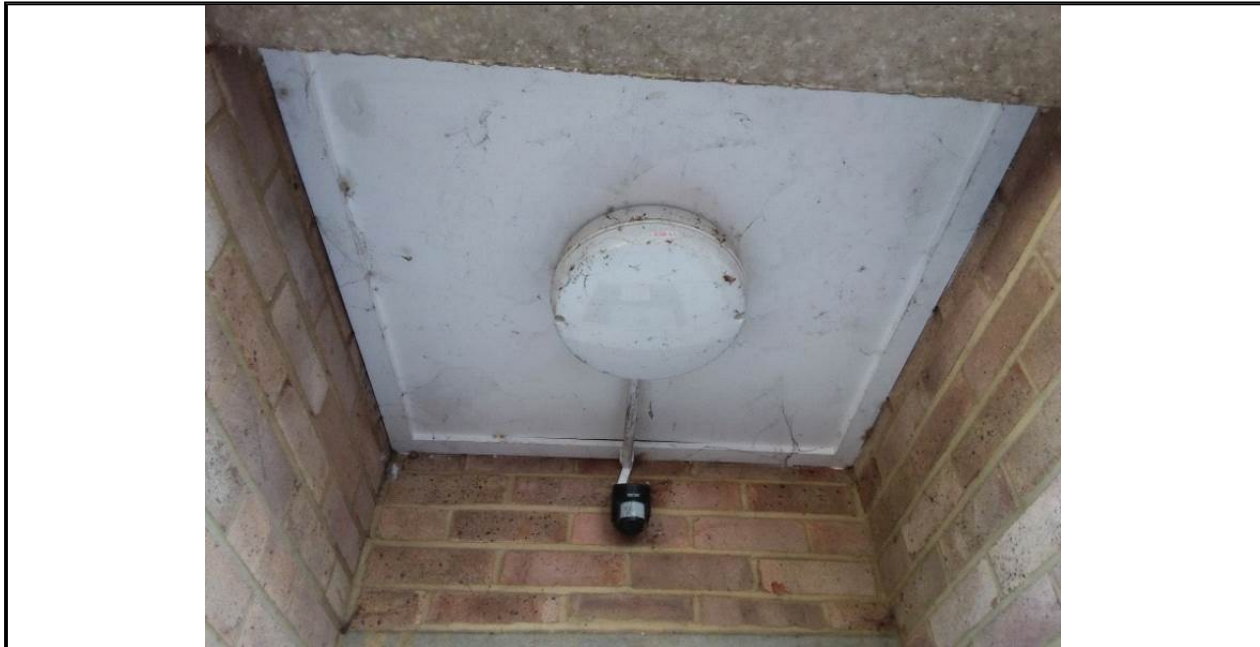
Sample No:	MH000197
Item No:	90
Survey Date:	03/09/18
Building:	Dove Lodge, 49 Beach Road, Littlehampton, BN16 3SD
Floor:	External
Room No:	External Elements
Position:	Fire Exit Ceiling Lining - Asbestos Insulating Board
Extent:	1.0m <sup>2</sup>
Substrate:	Nailed, Timber Batons
Material:	(2) Asbestos Insulating Board
Accessibility:	(1) Occasionally likely to be disturbed
Asbestos Type:	Chrysotile + Amosite
Risk Category:	Low
Recommended Action:	High risk ACM in good condition, encapsulation intact. Where appropriate label with warning signs. Undertake routine inspections for damage and deterioration. Work on this material requires a license & is notifiable to the appropriate enforcing authority. Disposal of asbestos waste by a licensed contractor only. All work must conform to the 'Control of Asbestos Regulations 2012'.

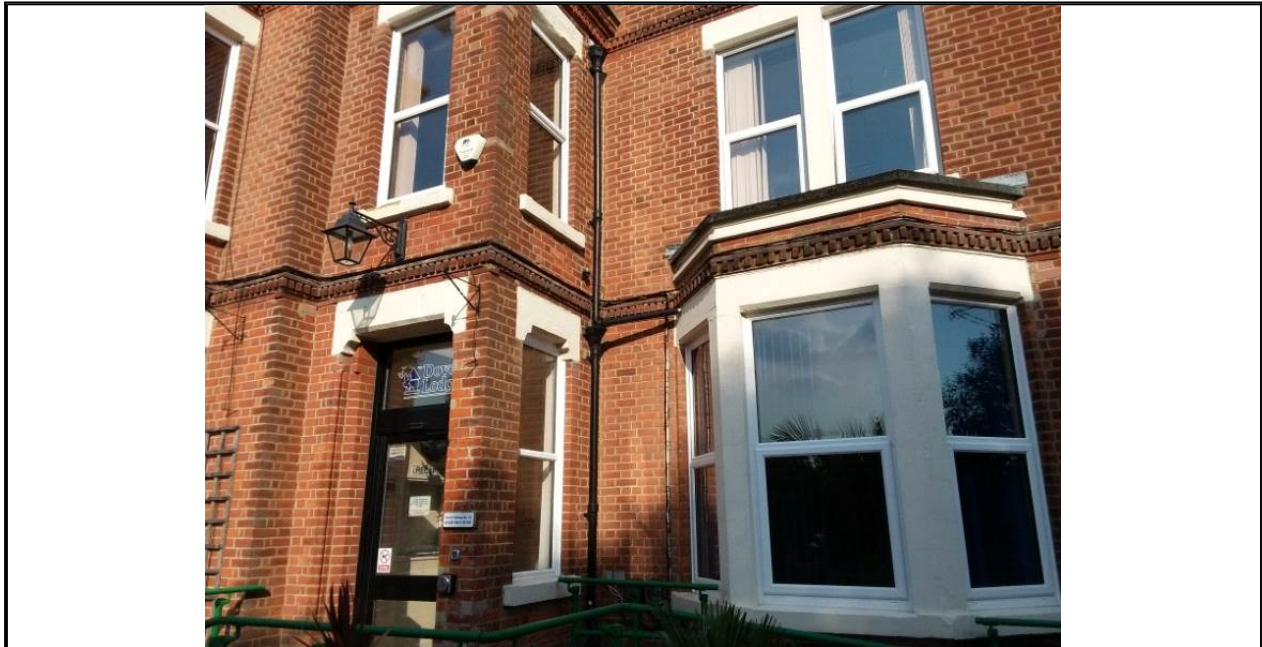
Sample No:	MH000198
Item No:	91
Survey Date:	03/09/18
Building:	Dove Lodge, 49 Beach Road, Littlehampton, BN16 3SD
Floor:	External
Room No:	External Elements
Position:	Downpipe to front of building - Cement
Extent:	6.0lm
Substrate:	Bolted, Brick
Material:	(1) Asbestos Cement
Accessibility:	(2) Easily disturbed
Asbestos Type:	Chrysotile
Risk Category:	Very Low
Recommended Action:	Low risk ACM (Bound in matrix). Where appropriate label with warning signs. Undertake routine inspections for damage and deterioration. Work on this material does not require a license. Work on this material may be notifiable to the appropriate enforcing authority. Disposal of asbestos waste by a licensed contractor only. All work must conform to the 'Control of Asbestos Regulations 2012'.

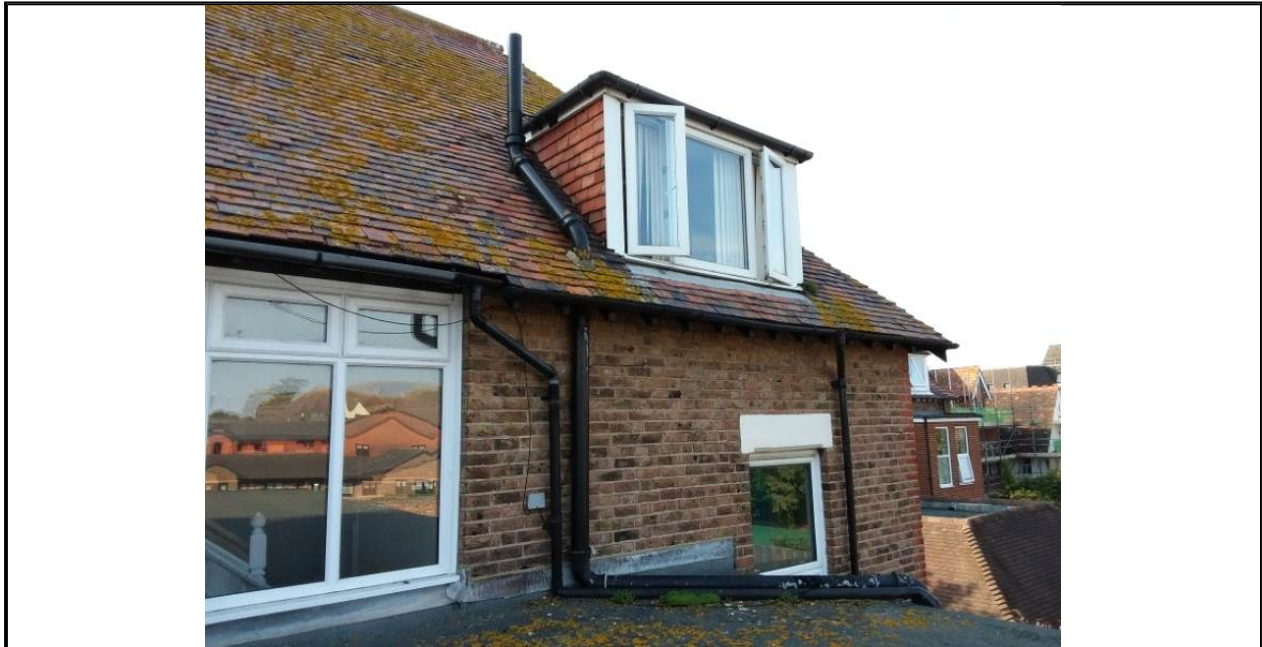
Sample No:	As MH000196
Item No:	93
Survey Date:	03/09/18
Building:	Dove Lodge, 49 Beach Road, Littlehampton, BN16 3SD
Floor:	External
Room No:	External Elements
Position:	Soilpipe over flat roof to main building - Cement
Extent:	5.0lm
Substrate:	Bolted, Brick
Material:	(1) Asbestos Cement
Accessibility:	(2) Easily disturbed
Asbestos Type:	Chrysotile + Crocidolite
Risk Category:	Very Low
Recommended Action:	Low risk ACM (Bound in matrix). Where appropriate label with warning signs. Undertake routine inspections for damage and deterioration. Work on this material does not require a license. Work on this material may be notifiable to the appropriate enforcing authority. Disposal of asbestos waste by a licensed contractor only. All work must conform to the 'Control of Asbestos Regulations 2012'.

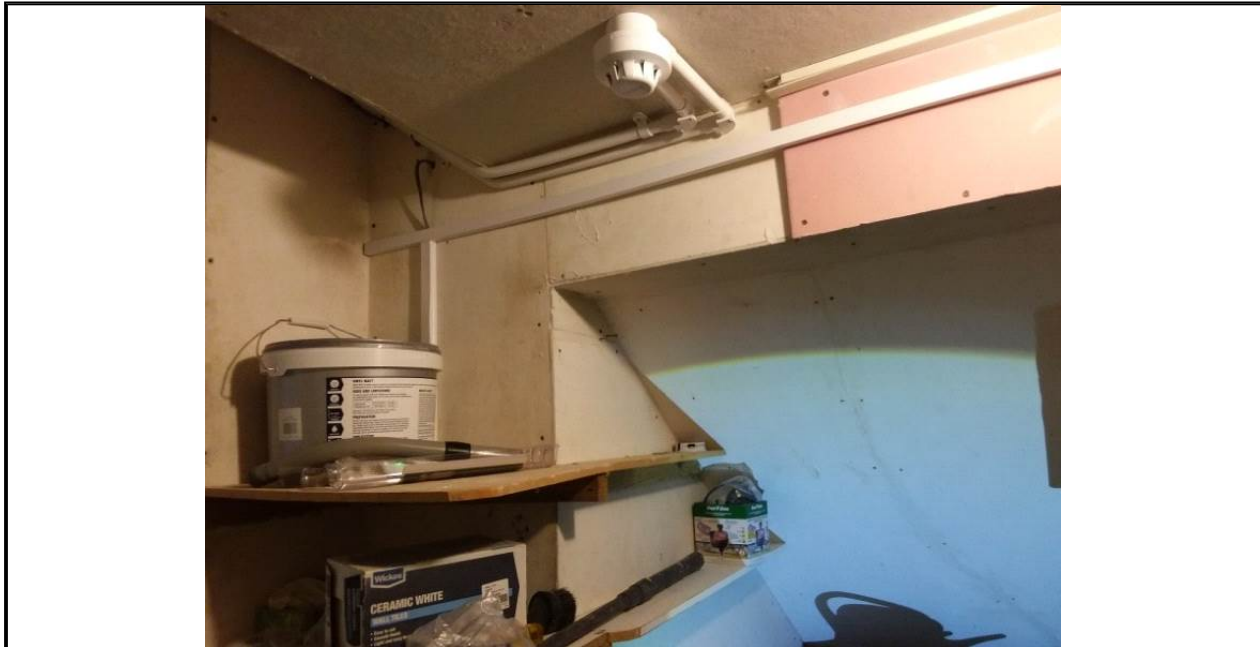
Sample No:	MH000188
Item No:	42
Survey Date:	03/09/18
Building:	Dove Lodge, 49 Beach Road, Littlehampton, BN16 3SD
Floor:	Ground Floor
Room No:	Hallway - Understairs Gas Cupboard
Position:	stair backing and wall lining - Asbestos Insulating Board
Extent:	9.0m <sup>2</sup>
Substrate:	Screwed, Timber Batons
Material:	(2) Asbestos Insulating Board
Accessibility:	(2) Easily disturbed
Asbestos Type:	Chrysotile + Amosite
Risk Category:	Low
Recommended Action:	Remove, repair or encapsulate by a licenced asbestos contractor under controlled conditions. Work on this material requires a license & is notifiable to the appropriate enforcing authority. Disposal of asbestos waste by a licensed contractor only. All work must conform to the 'Control of Asbestos Regulations 2012'.

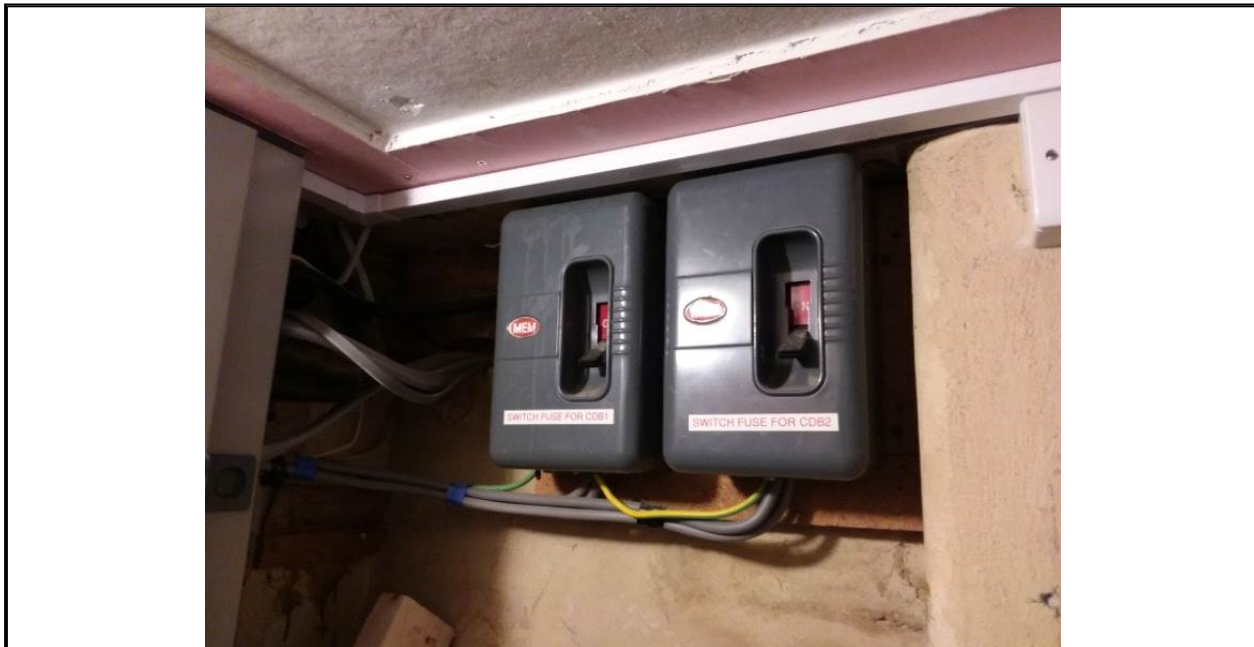
Sample No:	Presumed
Item No:	44
Survey Date:	03/09/18
Building:	Dove Lodge, 49 Beach Road, Littlehampton, BN16 3SD
Floor:	Ground Floor
Room No:	Hallway - Understairs Gas Cupboard
Position:	Flashguards - Textiles
Extent:	<1.0lm
Substrate:	Bonded, Metal
Material:	(2) Bonded, Metal
Accessibility:	(1) Occasionally likely to be disturbed
Asbestos Type:	Chrysotile
Risk Category:	Low
Recommended Action:	Inaccessible further investigation is required. To determine the material, access, sampling and analysis would be required. Until this is carried out it must be presumed to be an ACM (Asbestos Containing Material).

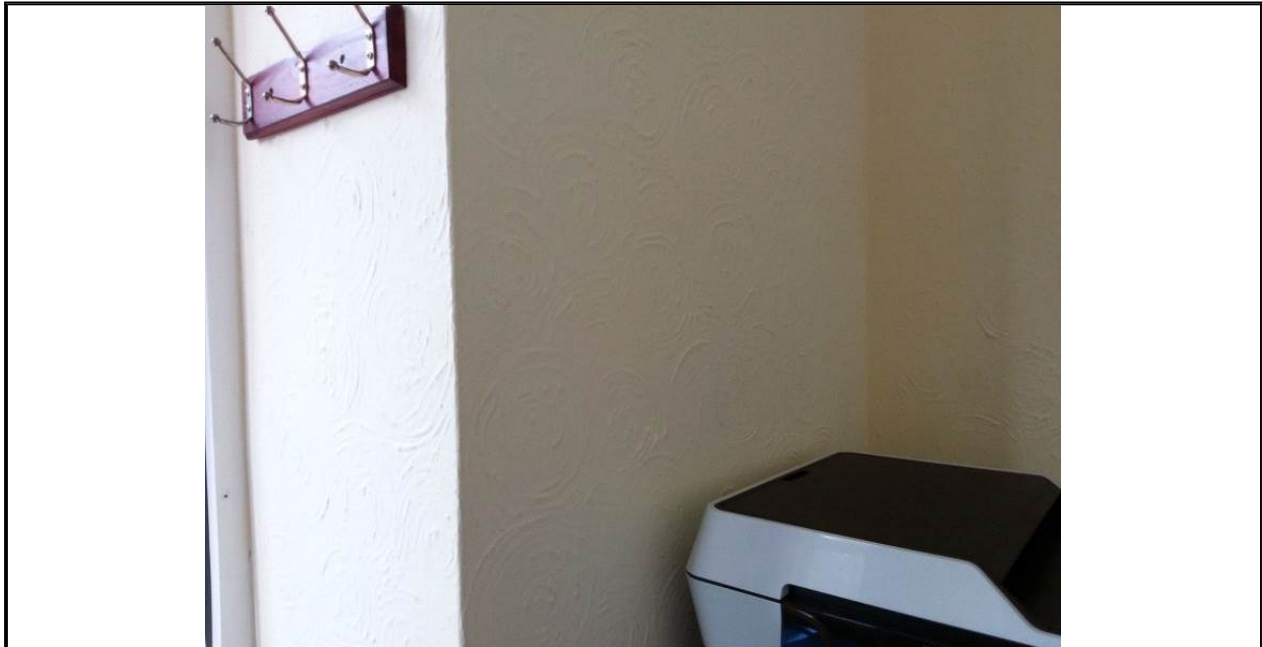
Sample No:	MH000190
Item No:	46
Survey Date:	03/09/18
Building:	Dove Lodge, 49 Beach Road, Littlehampton, BN16 3SD
Floor:	Ground Floor
Room No:	Dove Lodge Reception
Position:	to Walls - Textured Coating/Decorative Finish
Extent:	24.0m <sup>2</sup>
Substrate:	Bonded, Brick
Material:	(1) Textured Coating
Accessibility:	(2) Easily disturbed
Asbestos Type:	Chrysotile
Risk Category:	Low
Recommended Action:	Low risk ACM (Bound in matrix). Where appropriate label with warning signs. Undertake routine inspections for damage and deterioration. Work on this material does not require a license. Work on this material may be notifiable to the appropriate enforcing authority. Disposal of asbestos waste by a licensed contractor only. All work must conform to the 'Control of Asbestos Regulations 2012'.

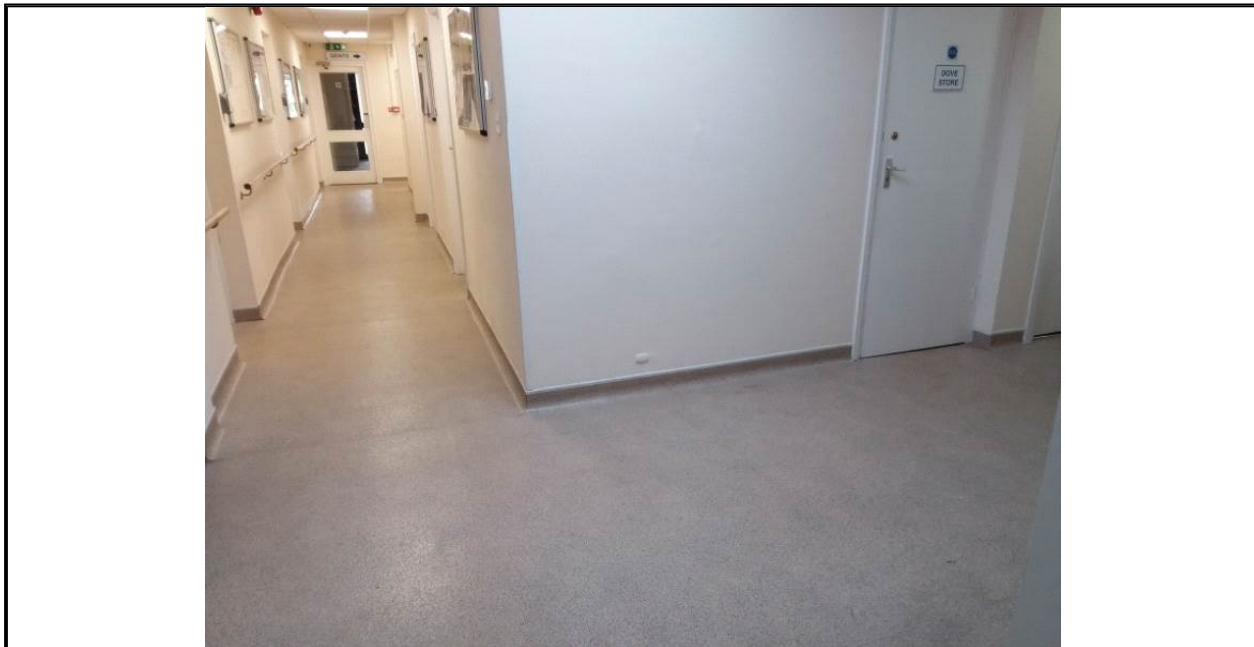
Sample No:	As MH000193
Item No:	85
Survey Date:	03/09/18
Building:	Dove Lodge, 49 Beach Road, Littlehampton, BN16 3SD
Floor:	Ground Floor
Room No:	Amberley Corridor
Position:	Floor tiles - Flooring - Thermoplastic
Extent:	50.0m <sup>2</sup>
Substrate:	Bonded, Concrete
Material:	(1) Well Bound Material
Accessibility:	(0) Usually inaccessible or unlikely to be disturbed
Asbestos Type:	Chrysotile
Risk Category:	Low
Recommended Action:	Low risk ACM (Bound in matrix). Where appropriate label with warning signs. Undertake routine inspections for damage and deterioration. Work on this material does not require a license. Work on this material may be notifiable to the appropriate enforcing authority. Disposal of asbestos waste by a licensed contractor only. All work must conform to the 'Control of Asbestos Regulations 2012'.

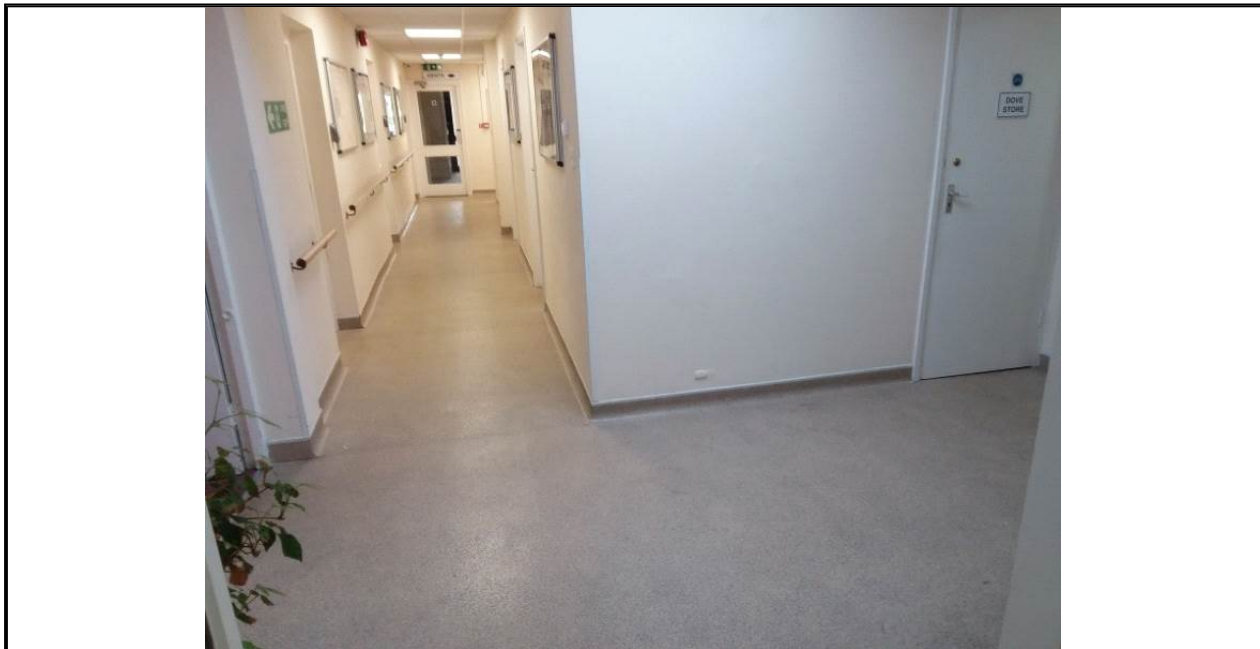
Sample No:	As MH000194
Item No:	86
Survey Date:	03/09/18
Building:	Dove Lodge, 49 Beach Road, Littlehampton, BN16 3SD
Floor:	Ground Floor
Room No:	Amberley Corridor
Position:	Floor Adhesive - Floor Adhesive
Extent:	50.0m <sup>2</sup>
Substrate:	Bonded, Concrete
Material:	(1) Well Bound Material
Accessibility:	(0) Usually inaccessible or unlikely to be disturbed
Asbestos Type:	Chrysotile
Risk Category:	Very Low
Recommended Action:	Low risk ACM (Bound in matrix). Where appropriate label with warning signs. Undertake routine inspections for damage and deterioration. Work on this material does not require a license. Work on this material may be notifiable to the appropriate enforcing authority. Disposal of asbestos waste by a licensed contractor only. All work must conform to the 'Control of Asbestos Regulations 2012'.

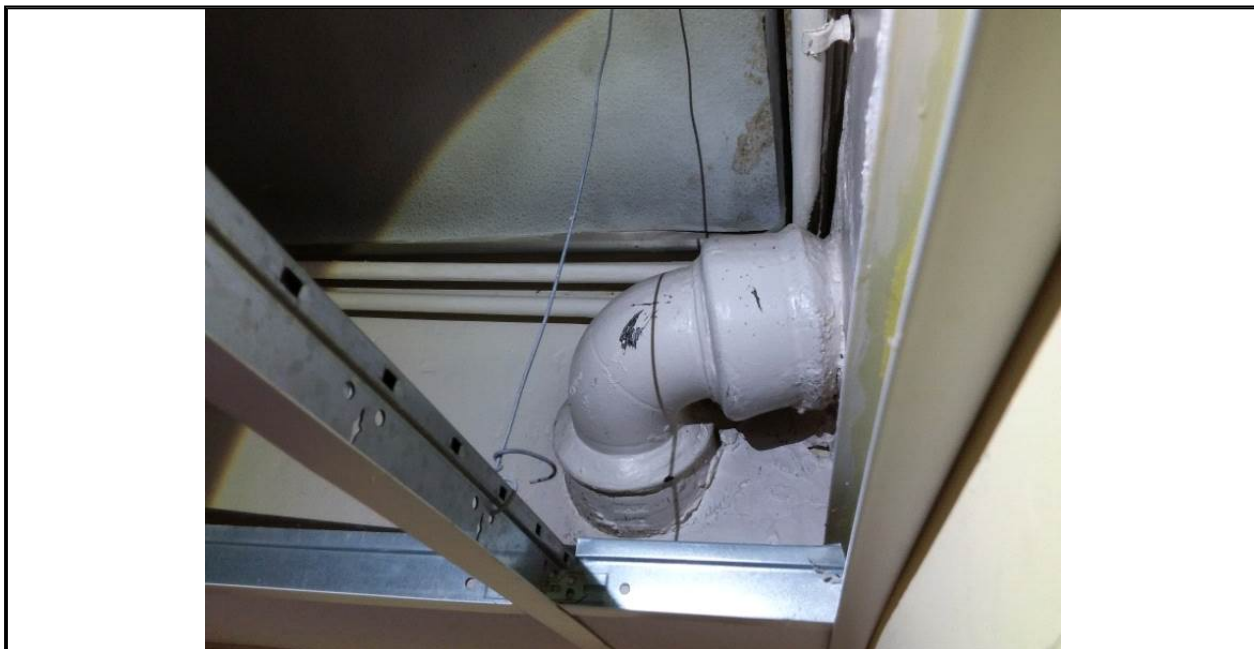
Sample No:	As MH000196
Item No:	92
Survey Date:	03/09/18
Building:	Dove Lodge, 49 Beach Road, Littlehampton, BN16 3SD
Floor:	Ground Floor
Room No:	Amberley Corridor - Fire Exit 1
Position:	Soilpipe to boiler room side - Cement
Extent:	1.0lm
Substrate:	Bolted, Brick
Material:	(1) Asbestos Cement
Accessibility:	(0) Usually inaccessible or unlikely to be disturbed
Asbestos Type:	Chrysotile + Crocidolite
Risk Category:	Low
Recommended Action:	Low risk ACM (Bound in matrix). Where appropriate label with warning signs. Undertake routine inspections for damage and deterioration. Work on this material does not require a license. Work on this material may be notifiable to the appropriate enforcing authority. Disposal of asbestos waste by a licensed contractor only. All work must conform to the 'Control of Asbestos Regulations 2012'.

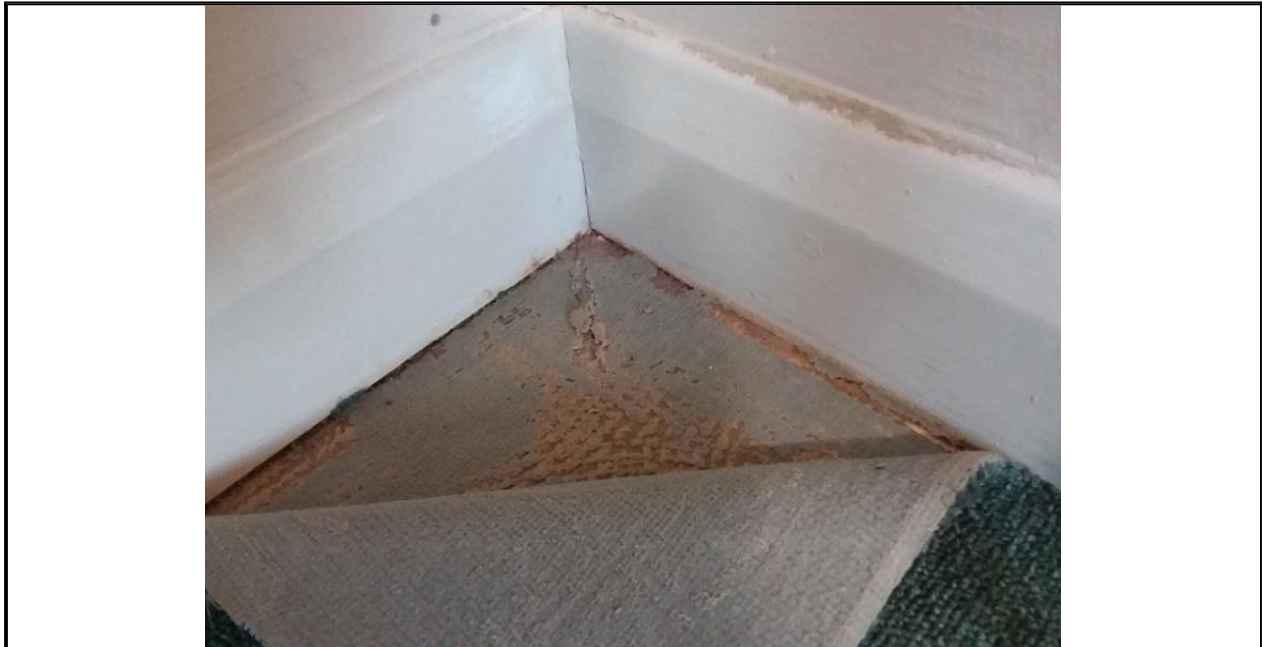
Sample No:	As MH000193
Item No:	83
Survey Date:	03/09/18
Building:	Dove Lodge, 49 Beach Road, Littlehampton, BN16 3SD
Floor:	Ground Floor
Room No:	Room 5
Position:	Floor tiles - Flooring - Thermoplastic
Extent:	15.0m <sup>2</sup>
Substrate:	Bonded, Concrete
Material:	(1) Well Bound Material
Accessibility:	(2) Easily disturbed
Asbestos Type:	Chrysotile
Risk Category:	Low
Recommended Action:	Low risk ACM (Bound in matrix). Where appropriate label with warning signs. Undertake routine inspections for damage and deterioration. Work on this material does not require a license. Work on this material may be notifiable to the appropriate enforcing authority. Disposal of asbestos waste by a licensed contractor only. All work must conform to the 'Control of Asbestos Regulations 2012'.
