## Management Survey

Site: 49 Beach Road, Littlehampton, BN16 3SD  
UPRN: N/A  
Client: Dove Lodge  
Report No: J012312  
Survey Date: 3rd September 2018  
Report Date: 4th September 2018  
Surveyors: Michael Hayward

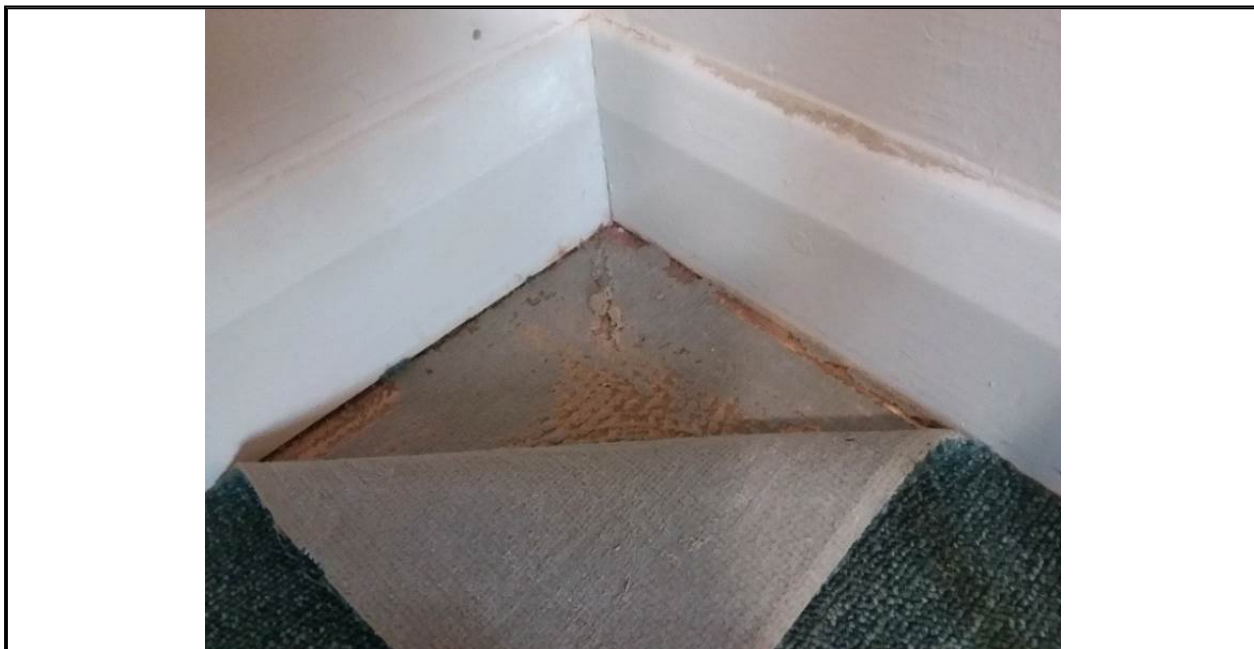
Sample No:	As MH000194
Item No:	84
Survey Date:	03/09/18
Building:	Dove Lodge, 49 Beach Road, Littlehampton, BN16 3SD
Floor:	Ground Floor
Room No:	Room 5
Position:	Floor Adhesive - Floor Adhesive
Extent:	15.0m <sup>2</sup>
Substrate:	Bonded, Concrete
Material:	(1) Well Bound Material
Accessibility:	(1) Occasionally likely to be disturbed
Asbestos Type:	Chrysotile
Risk Category:	Low
Recommended Action:	Low risk ACM (Bound in matrix). Where appropriate label with warning signs. Undertake routine inspections for damage and deterioration. Work on this material does not require a license. Work on this material may be notifiable to the appropriate enforcing authority. Disposal of asbestos waste by a licensed contractor only. All work must conform to the 'Control of Asbestos Regulations 2012'.

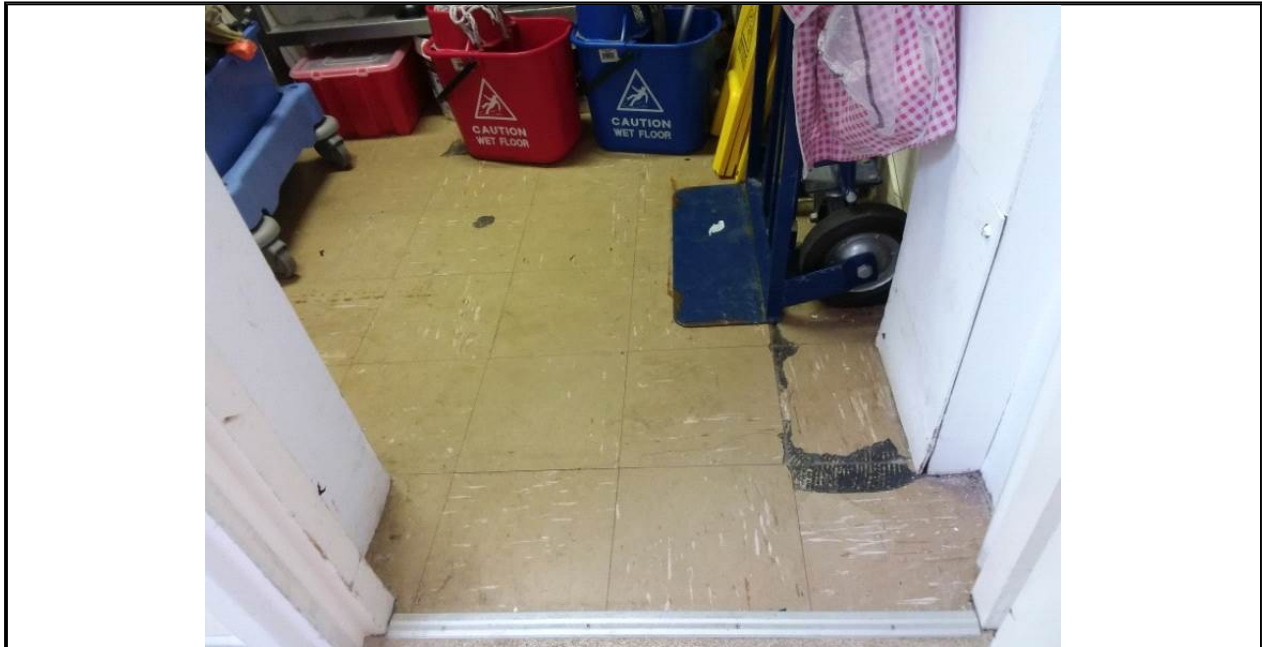
Sample No:	MH000193
Item No:	55
Survey Date:	03/09/18
Building:	Dove Lodge, 49 Beach Road, Littlehampton, BN16 3SD
Floor:	Ground Floor
Room No:	Dove Store
Position:	Floor tiles - Flooring - Thermoplastic
Extent:	6.0m <sup>2</sup>
Substrate:	Bonded, Concrete
Material:	(1) Well Bound Material
Accessibility:	(2) Easily disturbed
Asbestos Type:	Chrysotile
Risk Category:	Low
Recommended Action:	Low risk ACM (Bound in matrix). Where appropriate label with warning signs. Undertake routine inspections for damage and deterioration. Work on this material does not require a license. Work on this material may be notifiable to the appropriate enforcing authority. Disposal of asbestos waste by a licensed contractor only. All work must conform to the 'Control of Asbestos Regulations 2012'.

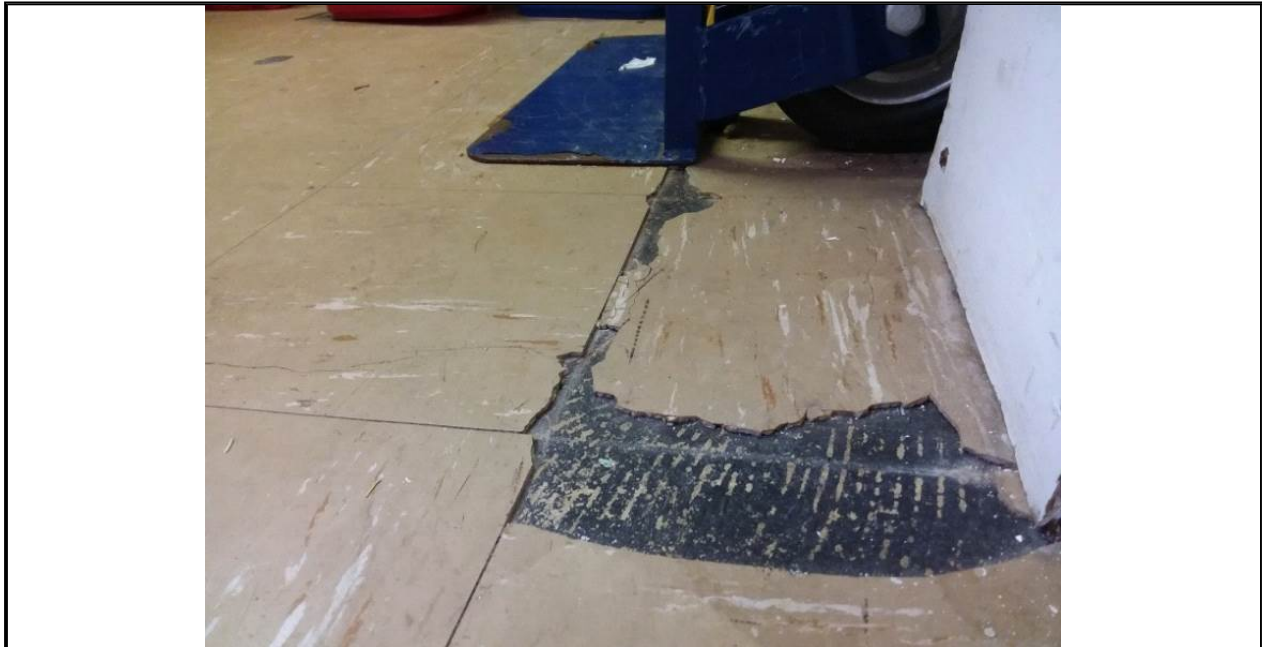
Sample No:	MH000194
Item No:	56
Survey Date:	03/09/18
Building:	Dove Lodge, 49 Beach Road, Littlehampton, BN16 3SD
Floor:	Ground Floor
Room No:	Dove Store
Position:	Floor Adhesive - Bitumen Products
Extent:	6.0m <sup>2</sup>
Substrate:	Bonded, Concrete
Material:	(1) Well Bound Material
Accessibility:	(2) Easily disturbed
Asbestos Type:	Chrysotile
Risk Category:	Very Low
Recommended Action:	Low risk ACM (Bound in matrix). Where appropriate label with warning signs. Undertake routine inspections for damage and deterioration. Work on this material does not require a license. Work on this material may be notifiable to the appropriate enforcing authority. Disposal of asbestos waste by a licensed contractor only. All work must conform to the 'Control of Asbestos Regulations 2012'.

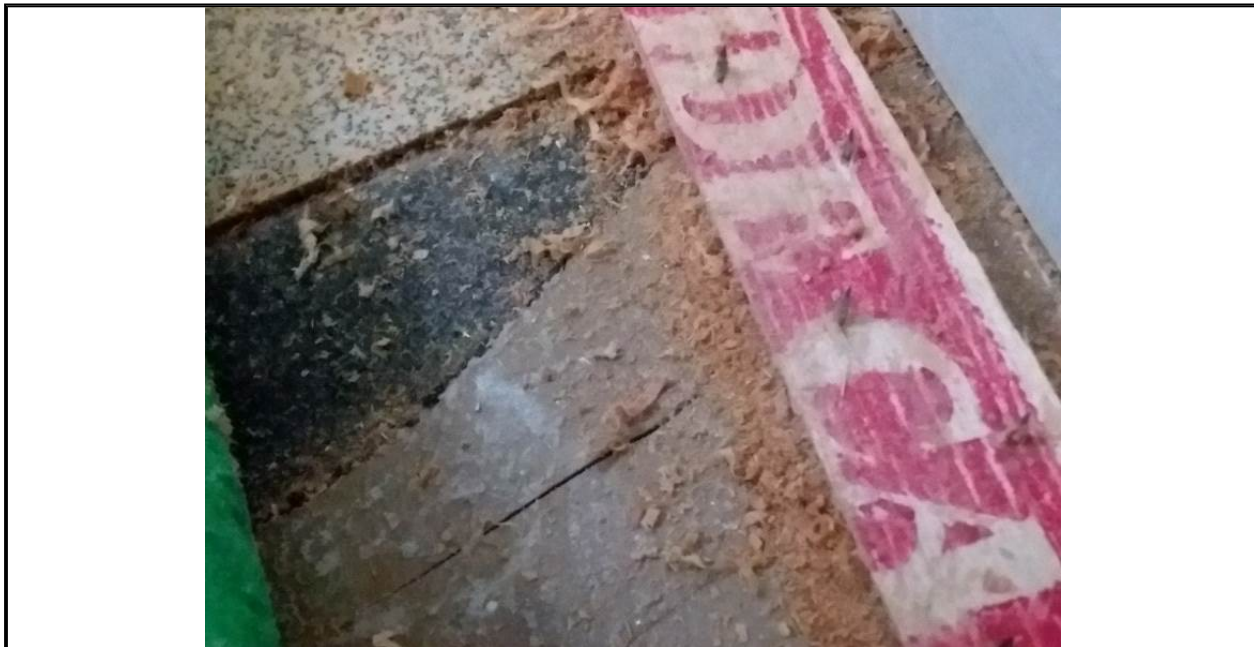
Sample No:	As MH000193
Item No:	58
Survey Date:	03/09/18
Building:	Dove Lodge, 49 Beach Road, Littlehampton, BN16 3SD
Floor:	Ground Floor
Room No:	Directors Office
Position:	Floor tiles - Flooring - Thermoplastic
Extent:	6.0m <sup>2</sup>
Substrate:	Bonded, Concrete
Material:	(1) Well Bound Material
Accessibility:	(1) Occasionally likely to be disturbed
Asbestos Type:	Chrysotile
Risk Category:	Low
Recommended Action:	Low risk ACM (Bound in matrix). Where appropriate label with warning signs. Undertake routine inspections for damage and deterioration. Work on this material does not require a license. Work on this material may be notifiable to the appropriate enforcing authority. Disposal of asbestos waste by a licensed contractor only. All work must conform to the 'Control of Asbestos Regulations 2012'.

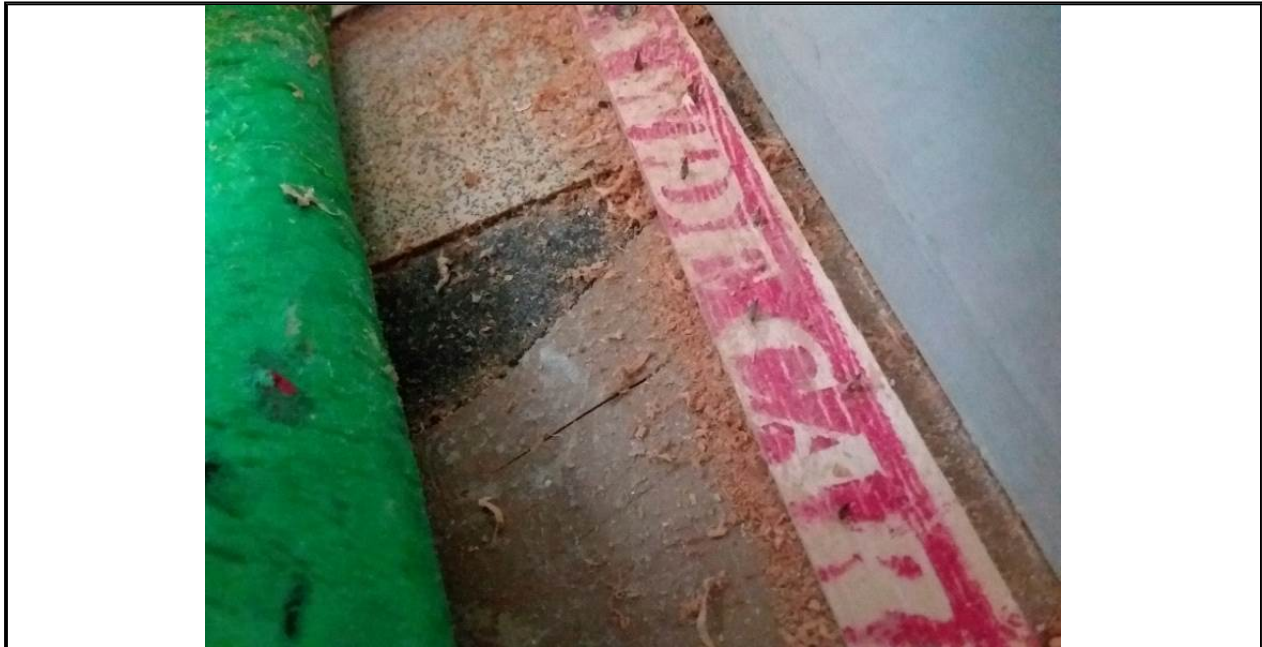
Sample No:	As MH000194
Item No:	59
Survey Date:	03/09/18
Building:	Dove Lodge, 49 Beach Road, Littlehampton, BN16 3SD
Floor:	Ground Floor
Room No:	Directors Office
Position:	Floor Adhesive - Bitumen Products
Extent:	6.0m <sup>2</sup>
Substrate:	Bonded, Concrete
Material:	(1) Well Bound Material
Accessibility:	(1) Occasionally likely to be disturbed
Asbestos Type:	Chrysotile
Risk Category:	Very Low
Recommended Action:	Low risk ACM (Bound in matrix). Where appropriate label with warning signs. Undertake routine inspections for damage and deterioration. Work on this material does not require a license. Work on this material may be notifiable to the appropriate enforcing authority. Disposal of asbestos waste by a licensed contractor only. All work must conform to the 'Control of Asbestos Regulations 2012'.

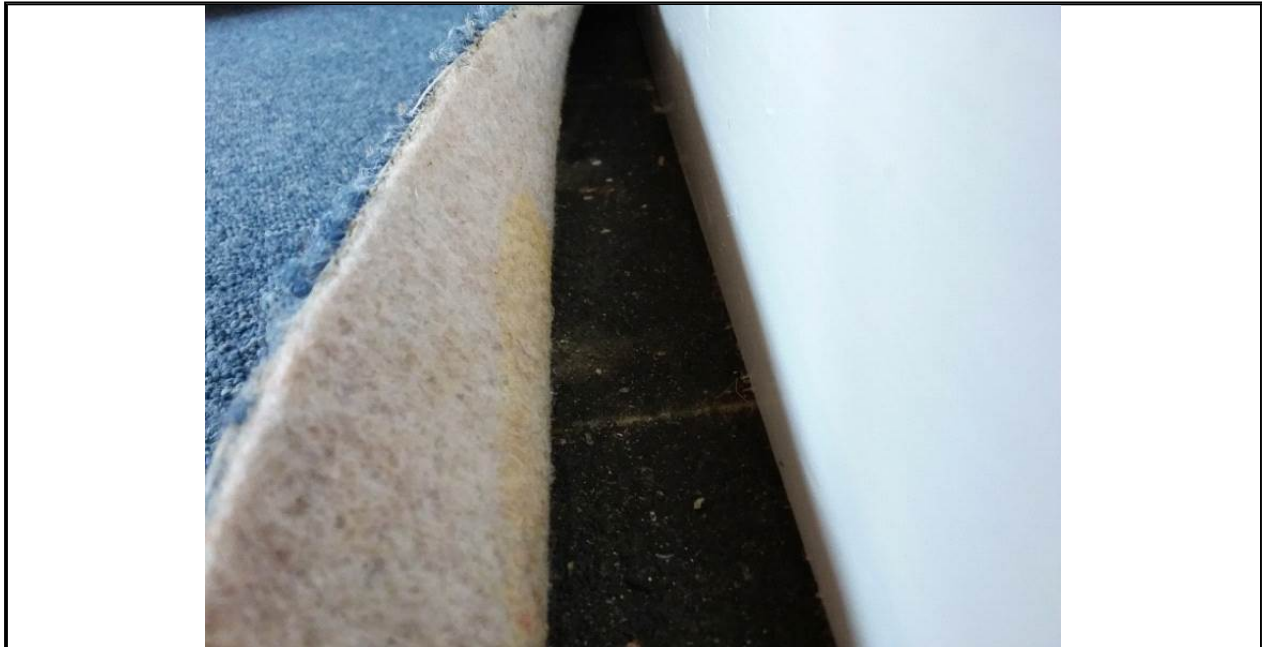
Sample No:	As MH000194
Item No:	64
Survey Date:	03/09/18
Building:	Dove Lodge, 49 Beach Road, Littlehampton, BN16 3SD
Floor:	Ground Floor
Room No:	Room 6
Position:	Floor Adhesive - Bitumen Products
Extent:	9.0m <sup>2</sup>
Substrate:	Bonded, Concrete
Material:	(1) Well Bound Material
Accessibility:	(1) Occasionally likely to be disturbed
Asbestos Type:	Chrysotile
Risk Category:	Low
Recommended Action:	Low risk ACM (Bound in matrix). Where appropriate label with warning signs. Undertake routine inspections for damage and deterioration. Work on this material does not require a license. Work on this material may be notifiable to the appropriate enforcing authority. Disposal of asbestos waste by a licensed contractor only. All work must conform to the 'Control of Asbestos Regulations 2012'.

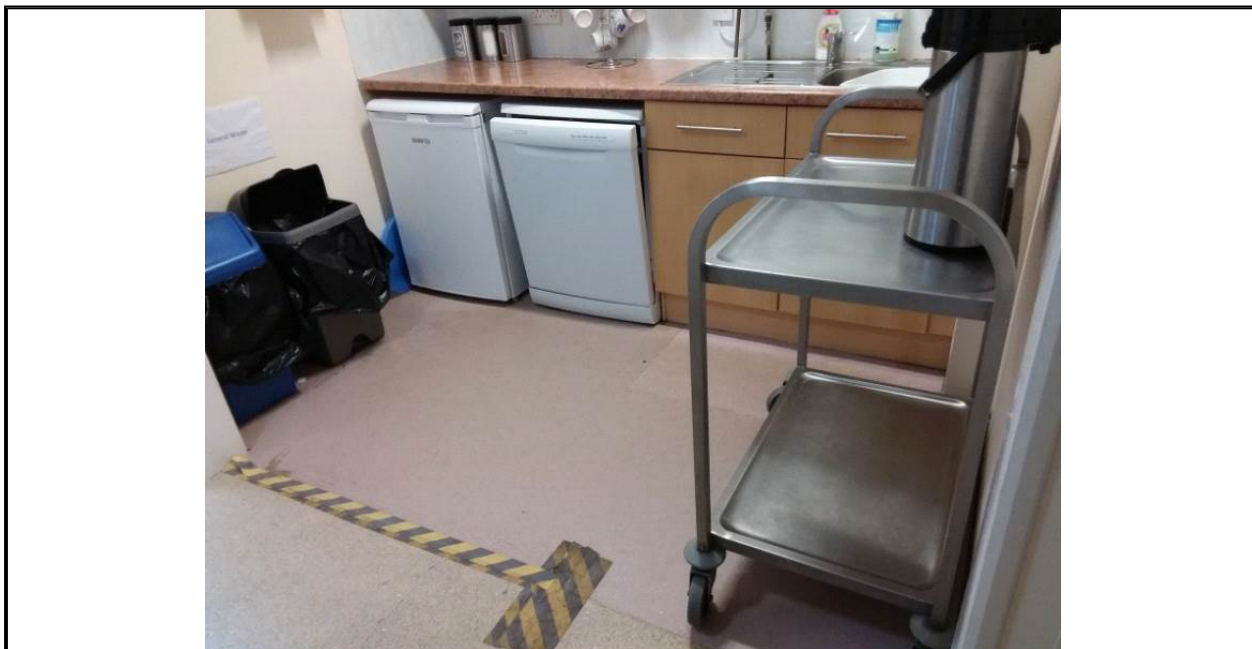
Sample No:	As MH000194
Item No:	77
Survey Date:	03/09/18
Building:	Dove Lodge, 49 Beach Road, Littlehampton, BN16 3SD
Floor:	Ground Floor
Room No:	Kitchenette
Position:	Floor Adhesive - Bitumen Products
Extent:	6.0m <sup>2</sup>
Substrate:	Bonded, Concrete
Material:	(1) Well Bound Material
Accessibility:	(2) Easily disturbed
Asbestos Type:	Chrysotile
Risk Category:	Very Low
Recommended Action:	Low risk ACM (Bound in matrix). Where appropriate label with warning signs. Undertake routine inspections for damage and deterioration. Work on this material does not require a license. Work on this material may be notifiable to the appropriate enforcing authority. Disposal of asbestos waste by a licensed contractor only. All work must conform to the 'Control of Asbestos Regulations 2012'.

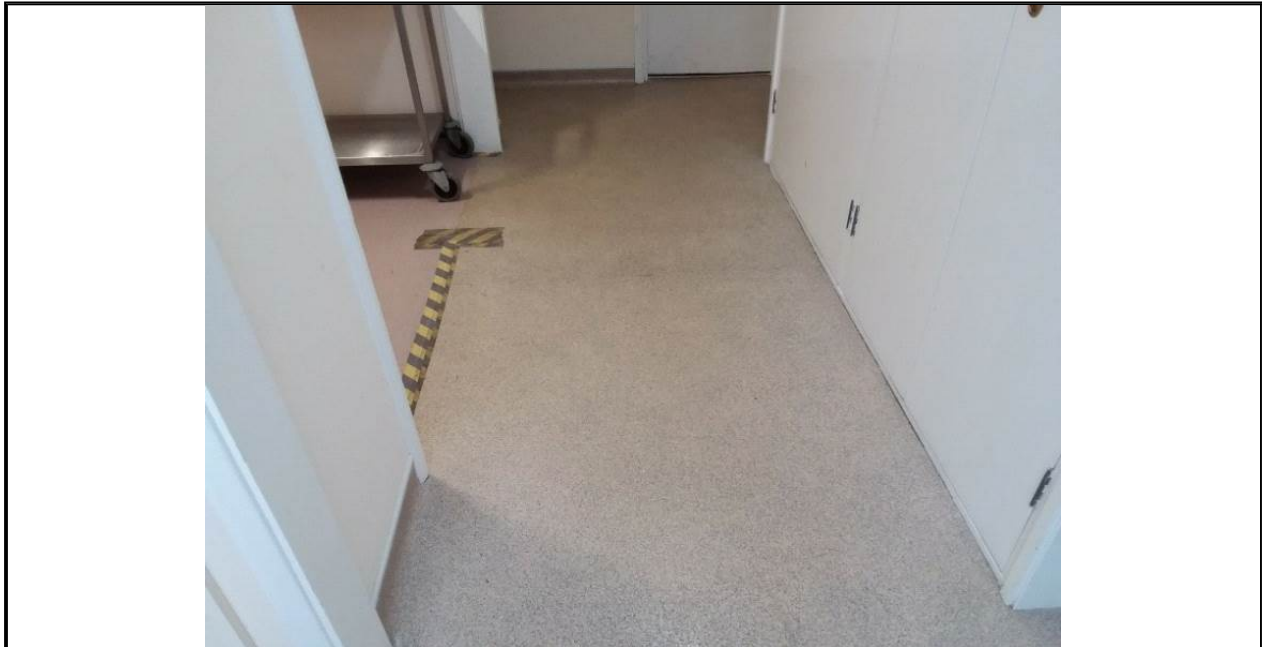
Sample No:	As MH000193
Item No:	79
Survey Date:	03/09/18
Building:	Dove Lodge, 49 Beach Road, Littlehampton, BN16 3SD
Floor:	Ground Floor
Room No:	kitchenette Lobby Corridor
Position:	Floor tiles - Flooring - Thermoplastic
Extent:	10.0m <sup>2</sup>
Substrate:	Bonded, Concrete
Material:	(1) Well Bound Material
Accessibility:	(0) Usually inaccessible or unlikely to be disturbed
Asbestos Type:	Chrysotile
Risk Category:	Very Low
Recommended Action:	Low risk ACM (Bound in matrix). Where appropriate label with warning signs. Undertake routine inspections for damage and deterioration. Work on this material does not require a license. Work on this material may be notifiable to the appropriate enforcing authority. Disposal of asbestos waste by a licensed contractor only. All work must conform to the 'Control of Asbestos Regulations 2012'.

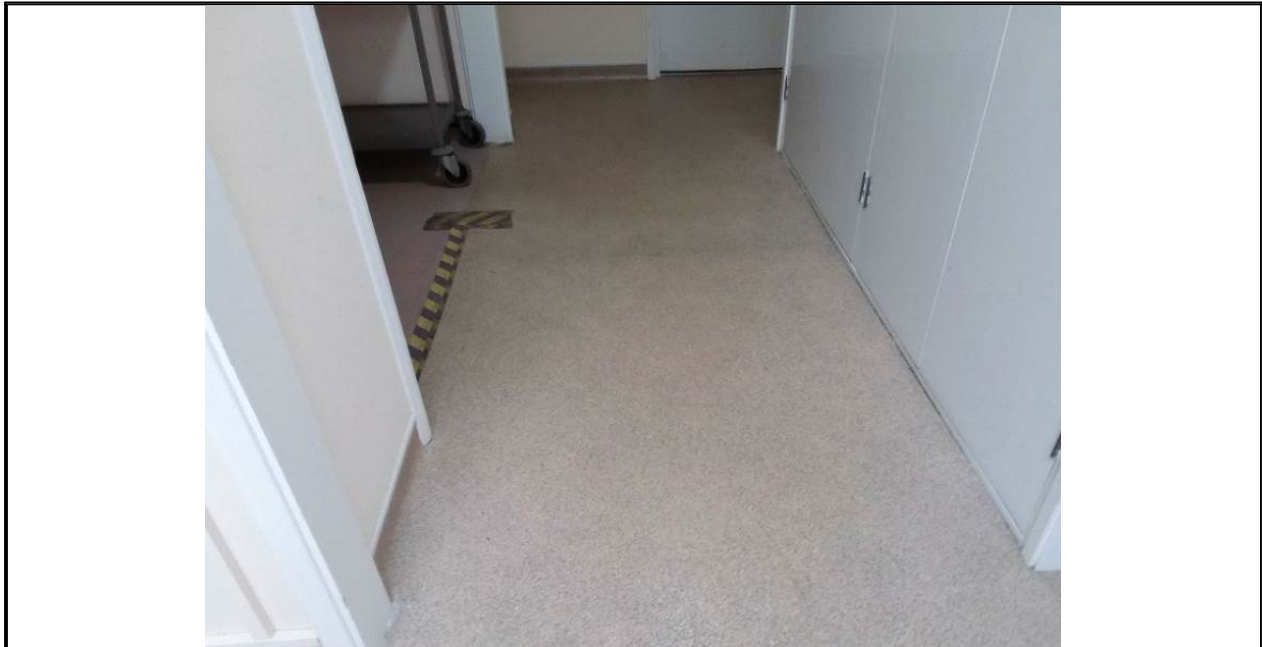
Sample No:	As MH000194
Item No:	80
Survey Date:	03/09/18
Building:	Dove Lodge, 49 Beach Road, Littlehampton, BN16 3SD
Floor:	Ground Floor
Room No:	kitchenette Lobby Corridor
Position:	Floor Adhesive - Bitumen Products
Extent:	10.0m <sup>2</sup>
Substrate:	Bonded, Concrete
Material:	(1) Well Bound Material
Accessibility:	(2) Easily disturbed
Asbestos Type:	Chrysotile
Risk Category:	Very Low
Recommended Action:	Low risk ACM (Bound in matrix). Where appropriate label with warning signs. Undertake routine inspections for damage and deterioration. Work on this material does not require a license. Work on this material may be notifiable to the appropriate enforcing authority. Disposal of asbestos waste by a licensed contractor only. All work must conform to the 'Control of Asbestos Regulations 2012'.

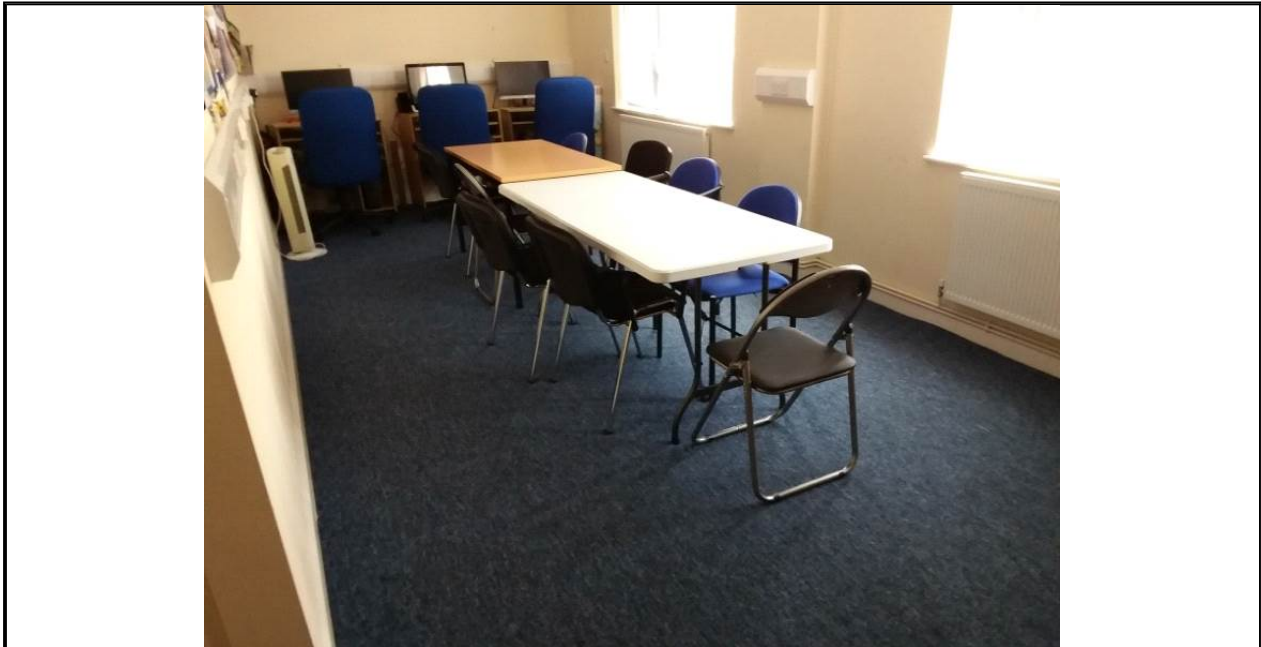
Sample No:	As MH000194
Item No:	78
Survey Date:	03/09/18
Building:	Dove Lodge, 49 Beach Road, Littlehampton, BN16 3SD
Floor:	Ground Floor
Room No:	Room 8 (including cupboard)
Position:	Floor Adhesive - Bitumen Products
Extent:	24.0m <sup>2</sup>
Substrate:	Bonded, Concrete
Material:	(1) Well Bound Material
Accessibility:	(1) Occasionally likely to be disturbed
Asbestos Type:	Chrysotile
Risk Category:	Low
Recommended Action:	Low risk ACM (Bound in matrix). Where appropriate label with warning signs. Undertake routine inspections for damage and deterioration. Work on this material does not require a license. Work on this material may be notifiable to the appropriate enforcing authority. Disposal of asbestos waste by a licensed contractor only. All work must conform to the 'Control of Asbestos Regulations 2012'.

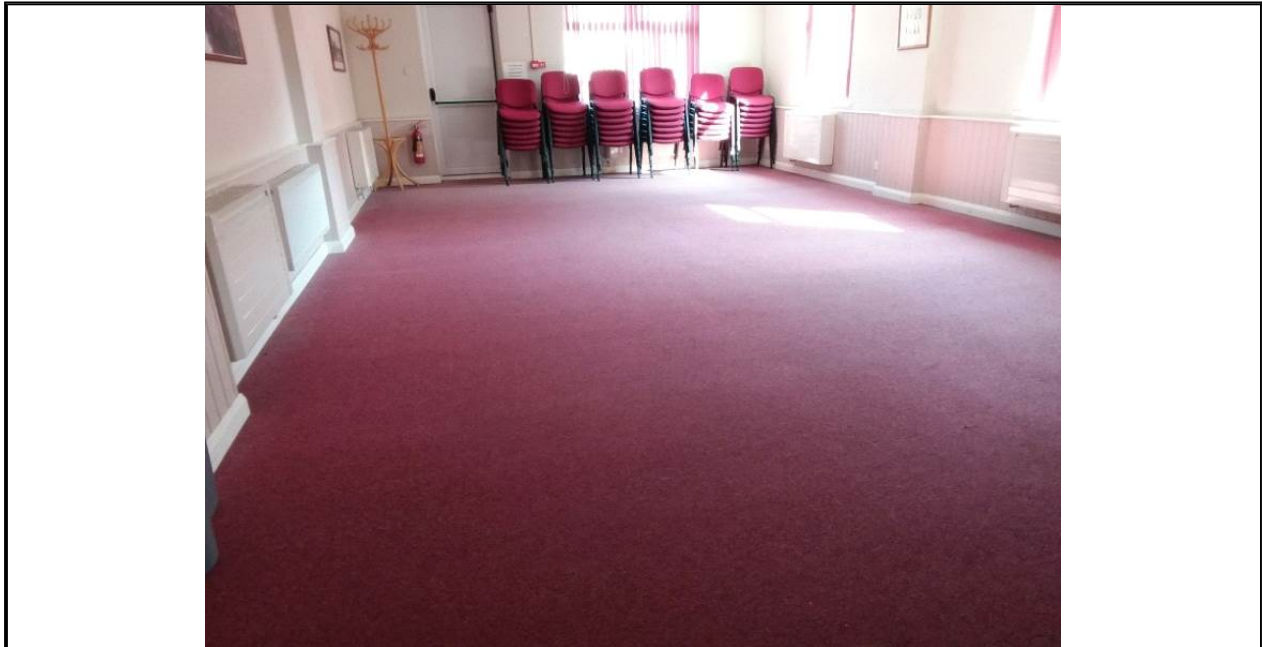
Sample No:	As MH000193
Item No:	81
Survey Date:	03/09/18
Building:	Dove Lodge, 49 Beach Road, Littlehampton, BN16 3SD
Floor:	Ground Floor
Room No:	The Amberley Room
Position:	Floor tiles - Flooring - Thermoplastic
Extent:	52.0m <sup>2</sup>
Substrate:	Bonded, Concrete
Material:	(1) Well Bound Material
Accessibility:	(1) Occasionally likely to be disturbed
Asbestos Type:	Chrysotile
Risk Category:	Low
Recommended Action:	Low risk ACM (Bound in matrix). Where appropriate label with warning signs. Undertake routine inspections for damage and deterioration. Work on this material does not require a license. Work on this material may be notifiable to the appropriate enforcing authority. Disposal of asbestos waste by a licensed contractor only. All work must conform to the 'Control of Asbestos Regulations 2012'.

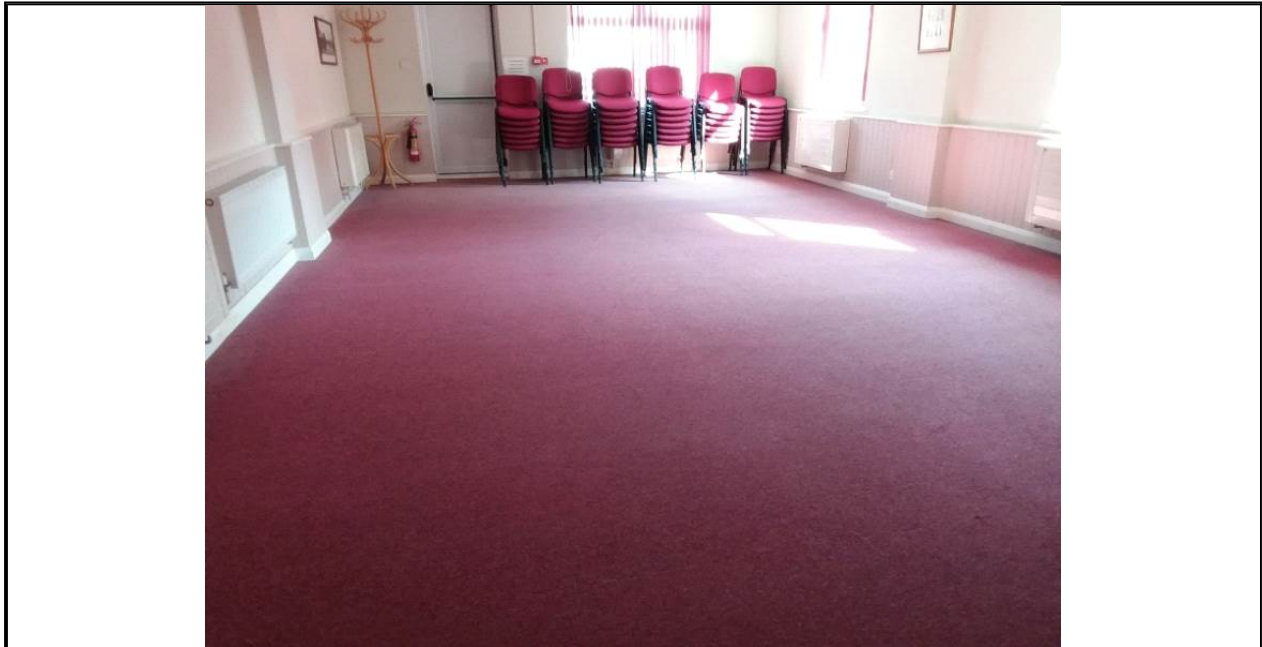
Sample No:	As MH000194
Item No:	82
Survey Date:	03/09/18
Building:	Dove Lodge, 49 Beach Road, Littlehampton, BN16 3SD
Floor:	Ground Floor
Room No:	The Amberley Room
Position:	Floor Adhesive - Bitumen Products
Extent:	52.0m <sup>2</sup>
Substrate:	Bonded, Concrete
Material:	(1) Well Bound Material
Accessibility:	(1) Occasionally likely to be disturbed
Asbestos Type:	Chrysotile
Risk Category:	Low
Recommended Action:	Low risk ACM (Bound in matrix). Where appropriate label with warning signs. Undertake routine inspections for damage and deterioration. Work on this material does not require a license. Work on this material may be notifiable to the appropriate enforcing authority. Disposal of asbestos waste by a licensed contractor only. All work must conform to the 'Control of Asbestos Regulations 2012'.

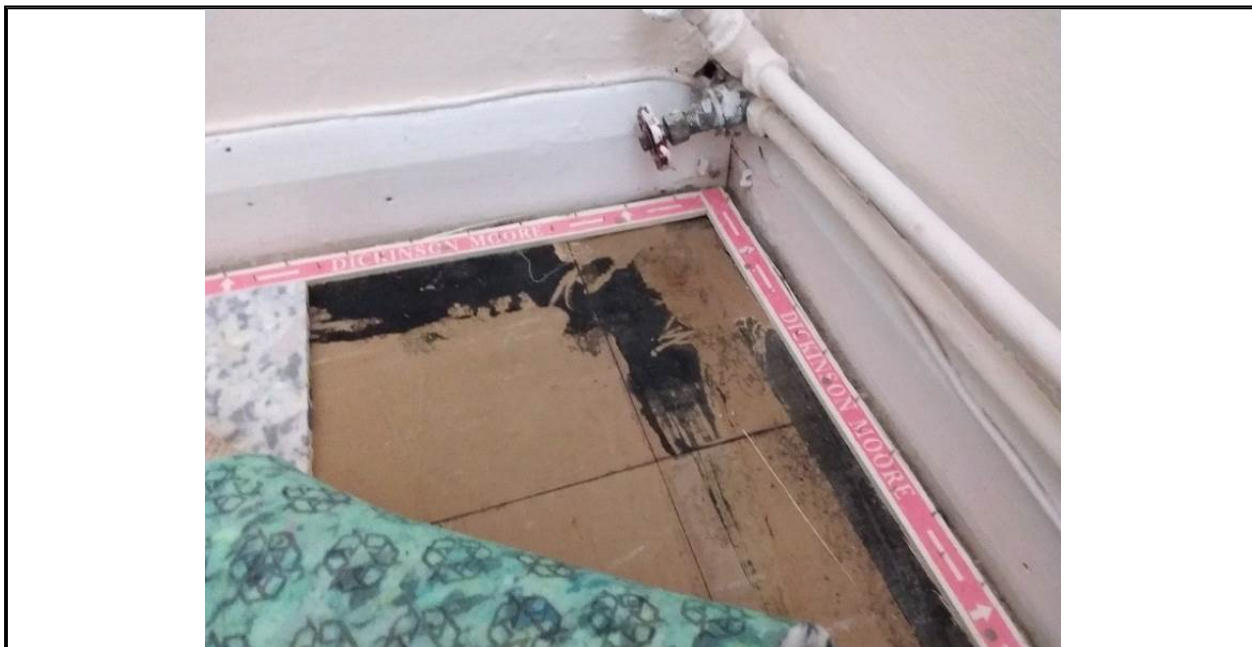
Sample No:	As MH000194
Item No:	70
Survey Date:	03/09/18
Building:	Dove Lodge, 49 Beach Road, Littlehampton, BN16 3SD
Floor:	Ground Floor
Room No:	Room 9
Position:	Floor Adhesive - Bitumen Products
Extent:	20.0m <sup>2</sup>
Substrate:	Bonded, Concrete
Material:	(1) Well Bound Material
Accessibility:	(1) Occasionally likely to be disturbed
Asbestos Type:	Chrysotile
Risk Category:	Low
Recommended Action:	Low risk ACM (Bound in matrix). Where appropriate label with warning signs. Undertake routine inspections for damage and deterioration. Work on this material does not require a license. Work on this material may be notifiable to the appropriate enforcing authority. Disposal of asbestos waste by a licensed contractor only. All work must conform to the 'Control of Asbestos Regulations 2012'.

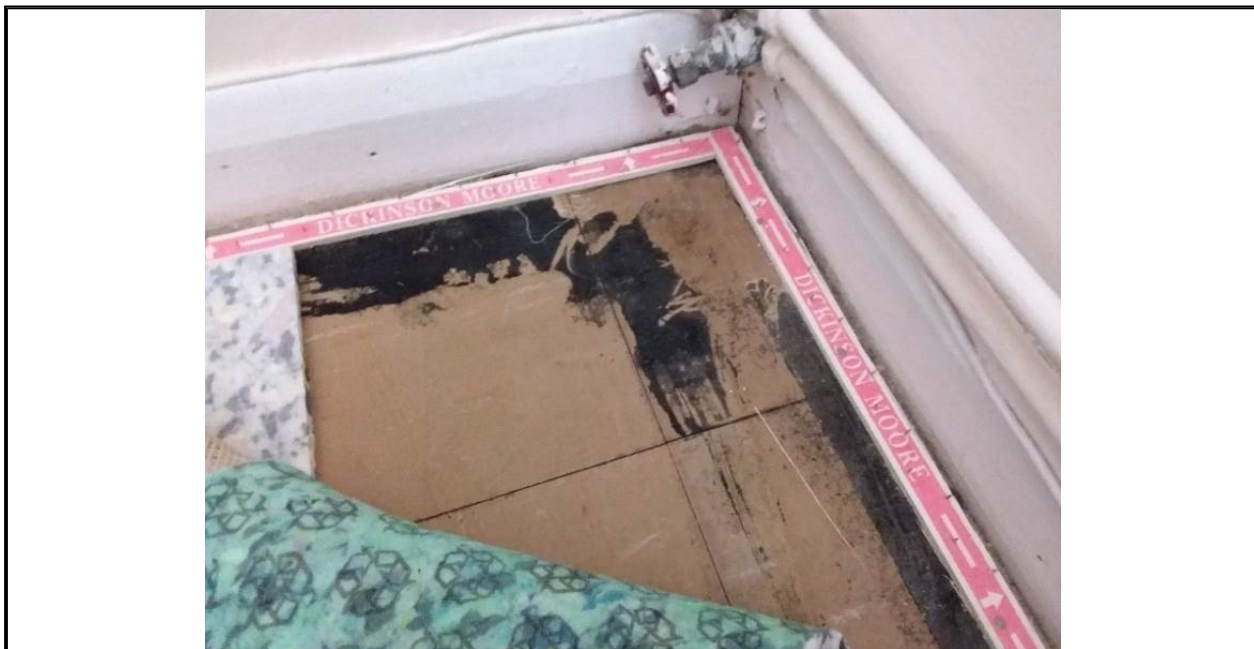
Sample No:	As MH000193
Item No:	71
Survey Date:	03/09/18
Building:	Dove Lodge, 49 Beach Road, Littlehampton, BN16 3SD
Floor:	Ground Floor
Room No:	Room 9
Position:	Floor tiles - Flooring - Thermoplastic
Extent:	20.0m <sup>2</sup>
Substrate:	Bonded, Concrete
Material:	(1) Well Bound Material
Accessibility:	(1) Occasionally likely to be disturbed
Asbestos Type:	Chrysotile
Risk Category:	Low
Recommended Action:	Low risk ACM (Bound in matrix). Where appropriate label with warning signs. Undertake routine inspections for damage and deterioration. Work on this material does not require a license. Work on this material may be notifiable to the appropriate enforcing authority. Disposal of asbestos waste by a licensed contractor only. All work must conform to the 'Control of Asbestos Regulations 2012'.

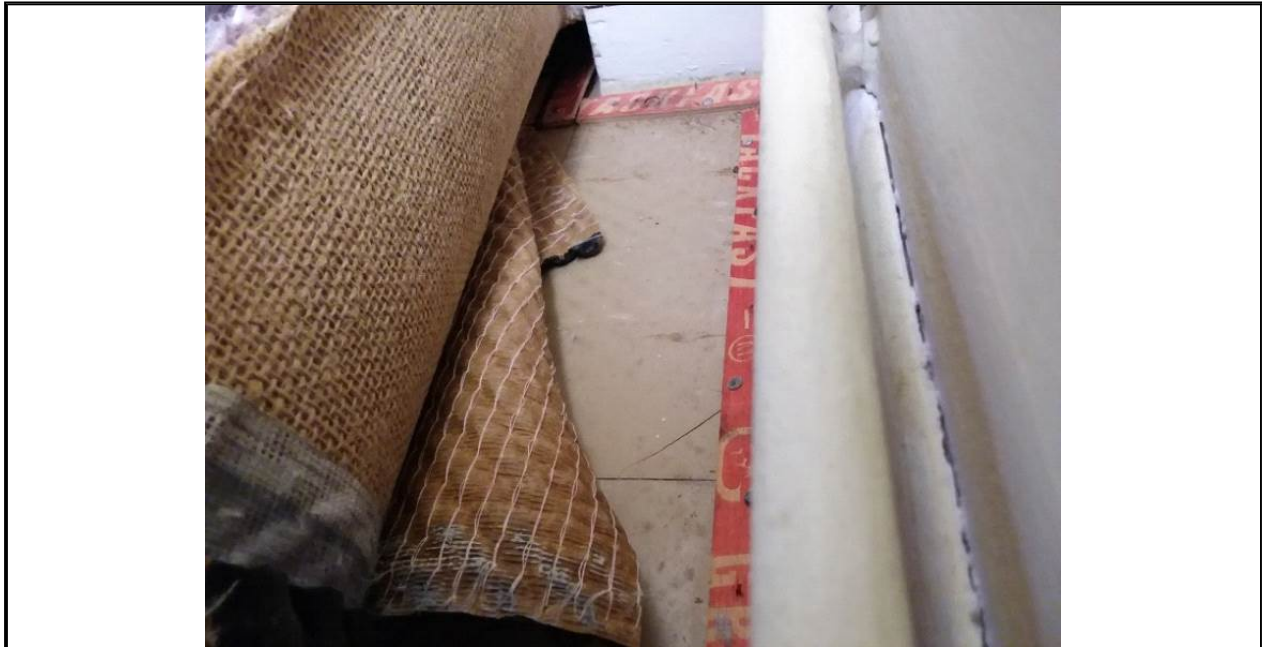
Sample No:	As MH000193
Item No:	72
Survey Date:	03/09/18
Building:	Dove Lodge, 49 Beach Road, Littlehampton, BN16 3SD
Floor:	Ground Floor
Room No:	Room 10
Position:	Floor tiles - Flooring - Thermoplastic
Extent:	20.0m <sup>2</sup>
Substrate:	Bonded, Concrete
Material:	(1) Well Bound Material
Accessibility:	(1) Occasionally likely to be disturbed
Asbestos Type:	Chrysotile
Risk Category:	Low
Recommended Action:	Low risk ACM (Bound in matrix). Where appropriate label with warning signs. Undertake routine inspections for damage and deterioration. Work on this material does not require a license. Work on this material may be notifiable to the appropriate enforcing authority. Disposal of asbestos waste by a licensed contractor only. All work must conform to the 'Control of Asbestos Regulations 2012'.

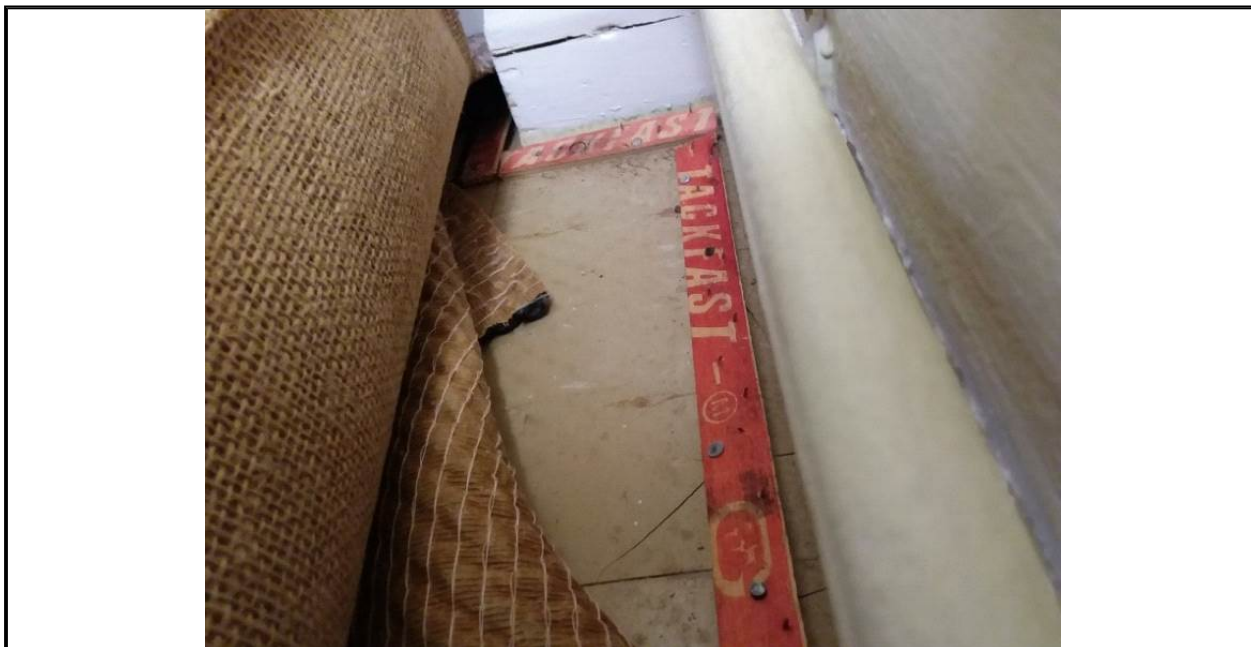
Sample No:	As MH000194
Item No:	73
Survey Date:	03/09/18
Building:	Dove Lodge, 49 Beach Road, Littlehampton, BN16 3SD
Floor:	Ground Floor
Room No:	Room 10
Position:	Floor Adhesive - Bitumen Products
Extent:	20.0m <sup>2</sup>
Substrate:	Bonded, Concrete
Material:	(1) Well Bound Material
Accessibility:	(1) Occasionally likely to be disturbed
Asbestos Type:	Chrysotile
Risk Category:	Low
Recommended Action:	Low risk ACM (Bound in matrix). Where appropriate label with warning signs. Undertake routine inspections for damage and deterioration. Work on this material does not require a license. Work on this material may be notifiable to the appropriate enforcing authority. Disposal of asbestos waste by a licensed contractor only. All work must conform to the 'Control of Asbestos Regulations 2012'.

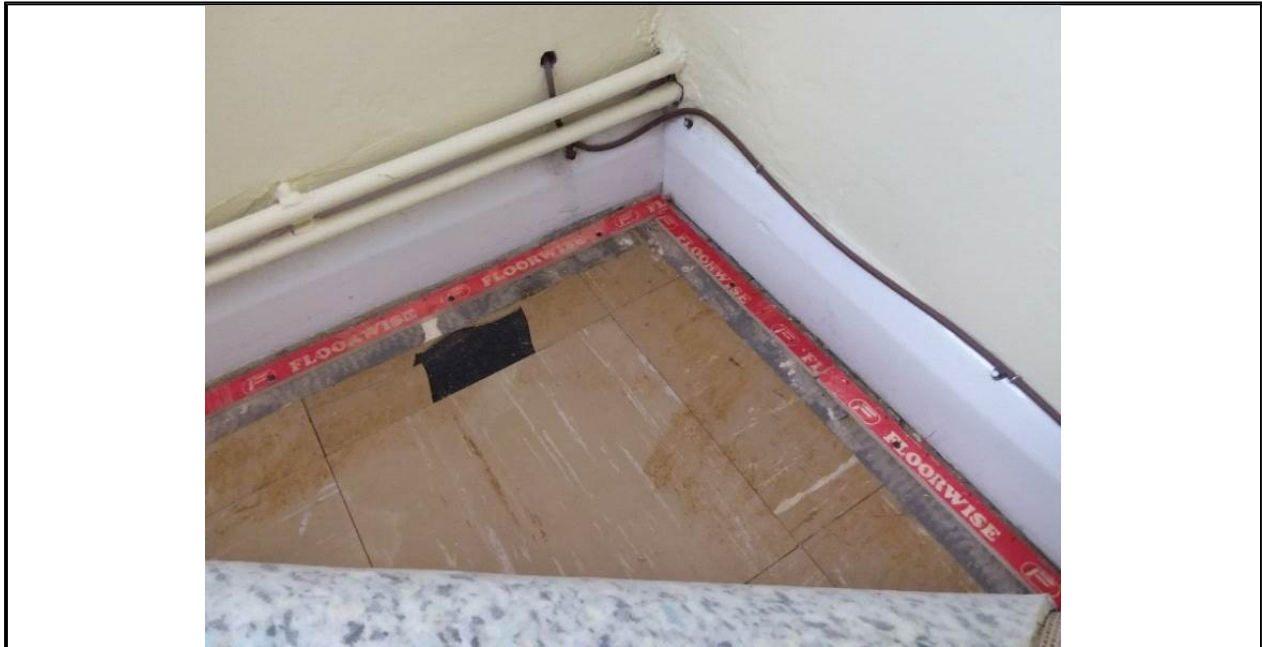
Sample No:	As MH000193
Item No:	74
Survey Date:	03/09/18
Building:	Dove Lodge, 49 Beach Road, Littlehampton, BN16 3SD
Floor:	Ground Floor
Room No:	Room 11
Position:	Floor tiles - Flooring - Thermoplastic
Extent:	20.0m <sup>2</sup>
Substrate:	Bonded, Concrete
Material:	(1) Well Bound Material
Accessibility:	(1) Occasionally likely to be disturbed
Asbestos Type:	Chrysotile
Risk Category:	Low
Recommended Action:	Low risk ACM (Bound in matrix). Where appropriate label with warning signs. Undertake routine inspections for damage and deterioration. Work on this material does not require a license. Work on this material may be notifiable to the appropriate enforcing authority. Disposal of asbestos waste by a licensed contractor only. All work must conform to the 'Control of Asbestos Regulations 2012'.

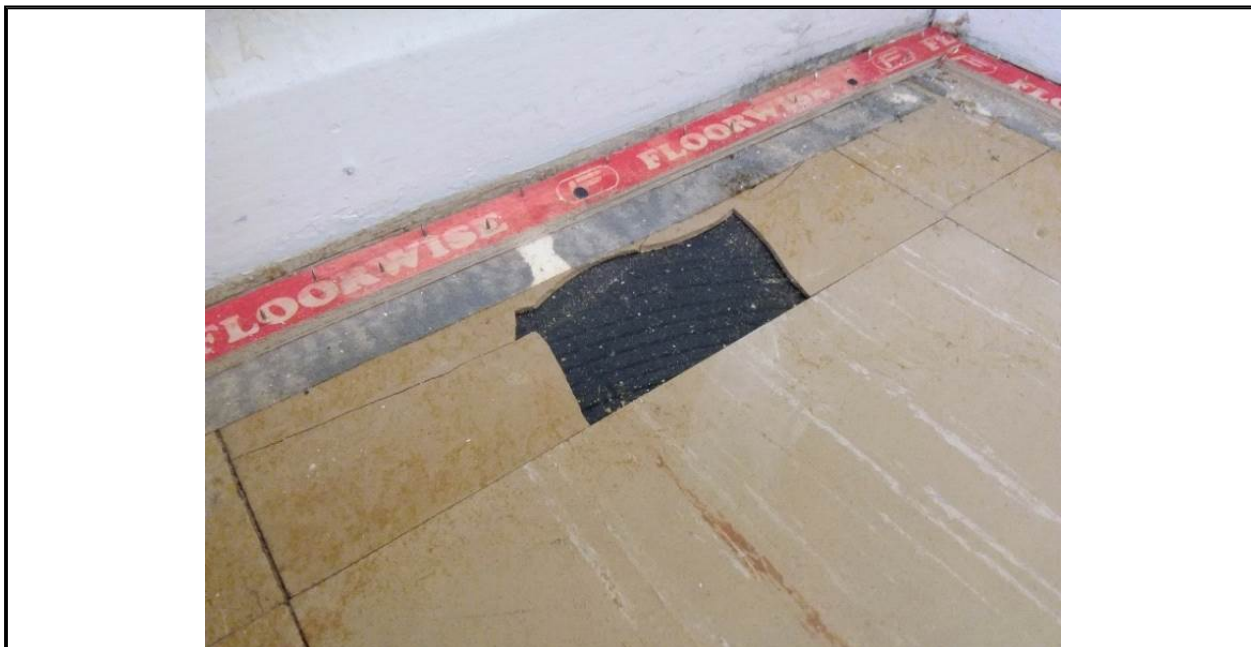
Sample No:	As MH000194
Item No:	75
Survey Date:	03/09/18
Building:	Dove Lodge, 49 Beach Road, Littlehampton, BN16 3SD
Floor:	Ground Floor
Room No:	Room 11
Position:	Floor Adhesive - Bitumen Products
Extent:	20.0m <sup>2</sup>
Substrate:	Bonded, Concrete
Material:	(1) Well Bound Material
Accessibility:	(1) Occasionally likely to be disturbed
Asbestos Type:	Chrysotile
Risk Category:	Low
Recommended Action:	Low risk ACM (Bound in matrix). Where appropriate label with warning signs. Undertake routine inspections for damage and deterioration. Work on this material does not require a license. Work on this material may be notifiable to the appropriate enforcing authority. Disposal of asbestos waste by a licensed contractor only. All work must conform to the 'Control of Asbestos Regulations 2012'.

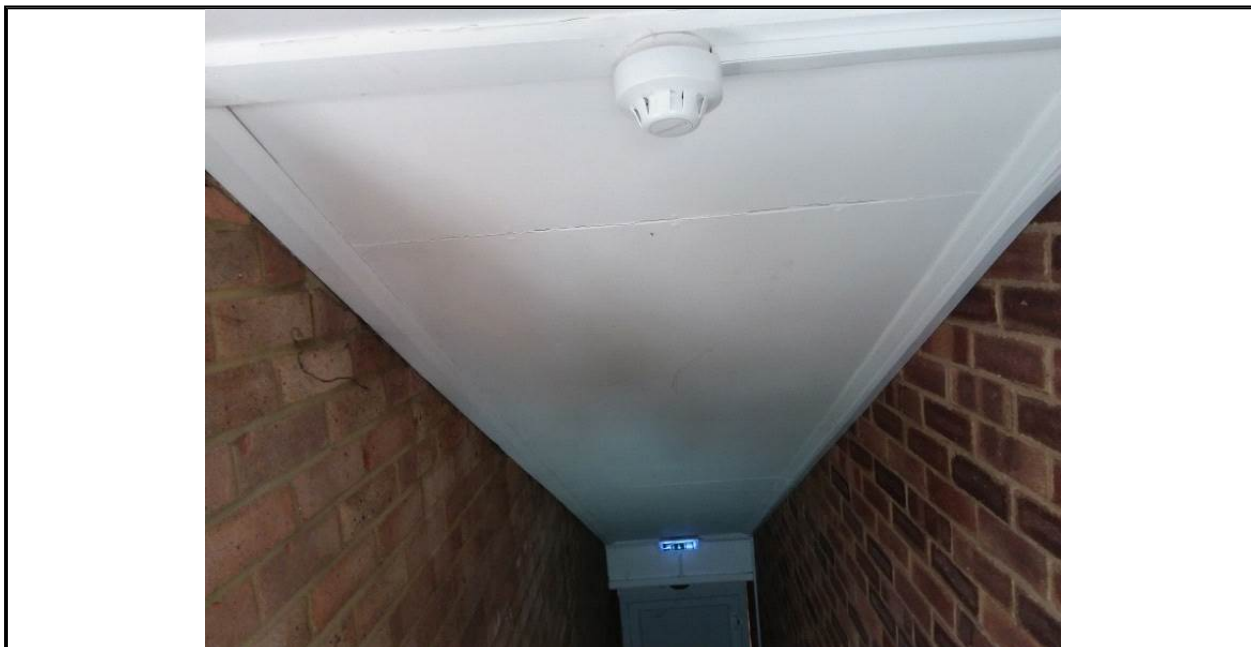
Sample No:	MH000187
Item No:	32
Survey Date:	03/09/18
Building:	Dove Lodge, 49 Beach Road, Littlehampton, BN16 3SD
Floor:	1st Floor
Room No:	Area 2 - Fire Exit Stairwell to Ground Floor
Position:	Ceiling lining - Asbestos Insulating Board
Extent:	6.0m <sup>2</sup>
Substrate:	Nailed, Timber Batons
Material:	(2) Asbestos Insulating Board
Accessibility:	(2) Easily disturbed
Asbestos Type:	Chrysotile + Amosite
Risk Category:	Low
Recommended Action:	High risk ACM in good condition, encapsulation intact. Where appropriate label with warning signs. Undertake routine inspections for damage and deterioration. Work on this material requires a license & is notifiable to the appropriate enforcing authority. Disposal of asbestos waste by a licensed contractor only. All work must conform to the 'Control of Asbestos Regulations 2012'.

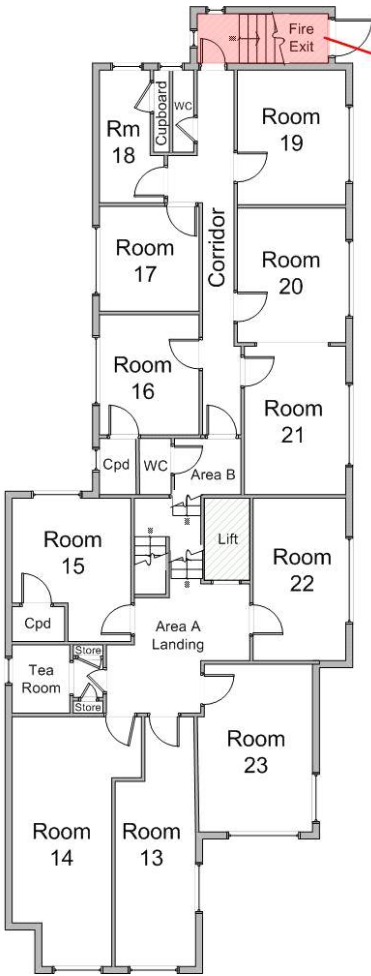
First Floor

MH00187 –  
Insulating Board  
Ceiling Lining
